**Esquimalt Lagoon Bridge
North Abutment Area
Storm Damage of January 2010**

Prepared by:

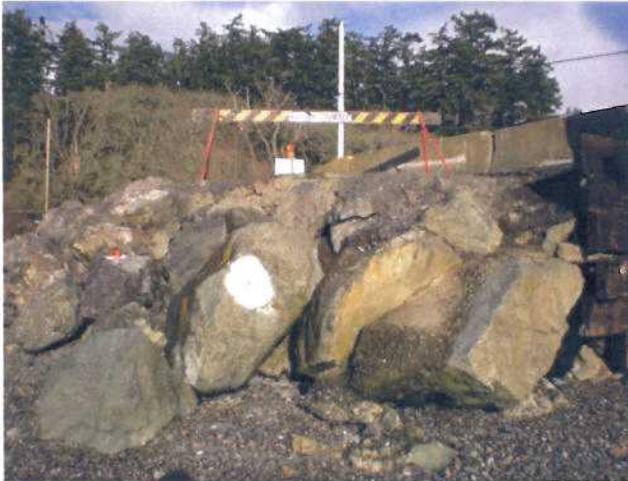
P1 - North Abutment Approach, Lagoon side.
Beach gravel erosion (lowering) causing movement of rip-rap.

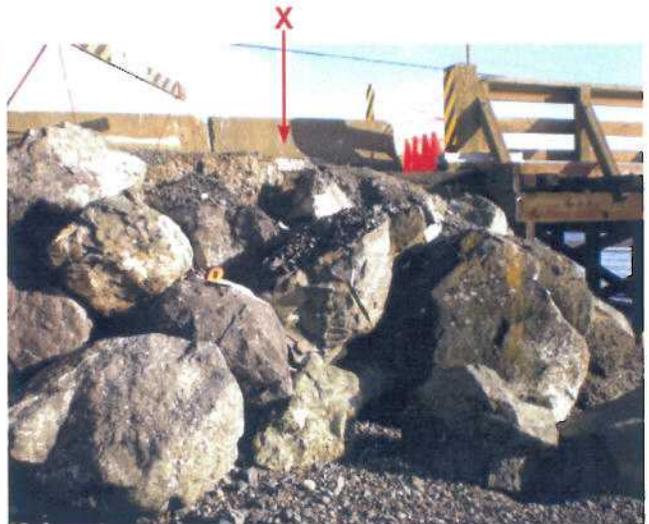
P2 - North Abutment Approach, Lagoon side,
side view. 'X' shows cleft caused by loss of backfill fines into voids between rip-rap blocks.

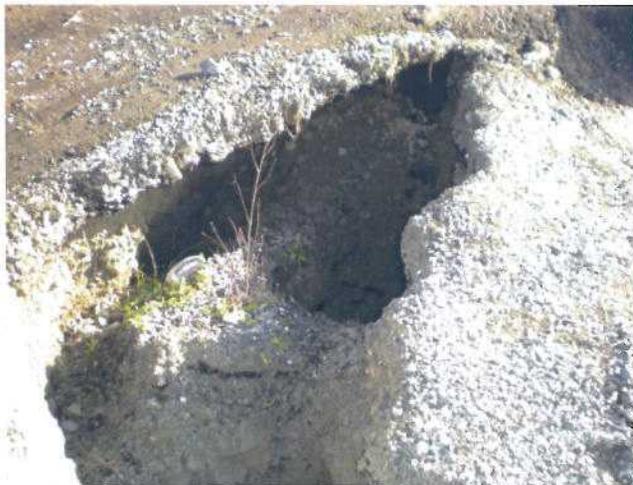
P3 - North Abutment Approach, Lagoon side.
Cleft in backfill fines at edge of pathway asphalt.
Cleft approximately 400 mm wide.

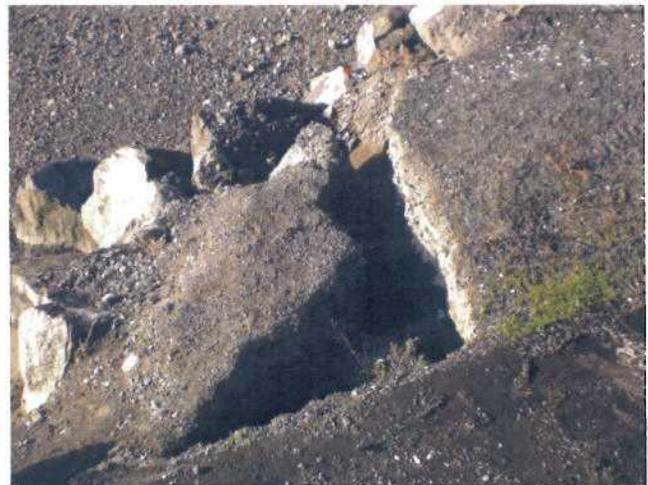
P4 - North Abutment Approach, Lagoon side,
side view. Shows cleft caused by loss of backfill fines into voids between rip-rap blocks.

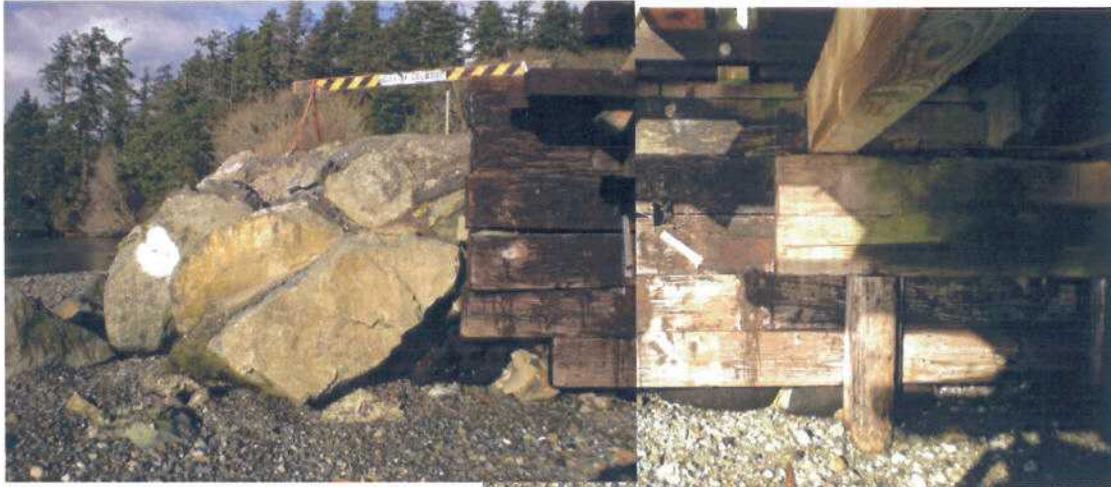
P5 - North Abutment, Lagoon side. Showing (on left) large rip-rap and timber 4x12 cantilevering from behind piled abutment. Beach level has been eroded away causing rip-rap to move and promoting erosion of fines into voids.
