File: DP000016 - Pool and Accessory Building at 3341 Betula Pl

DEVELOPMENT PERMIT DP000016

Re: 3341 Betula Place, Colwood, Construction of pool and accessory structure.

Re: Proposed Accessory Building Geotechnical Assessment
3341 Betula Place – Colwood, BC

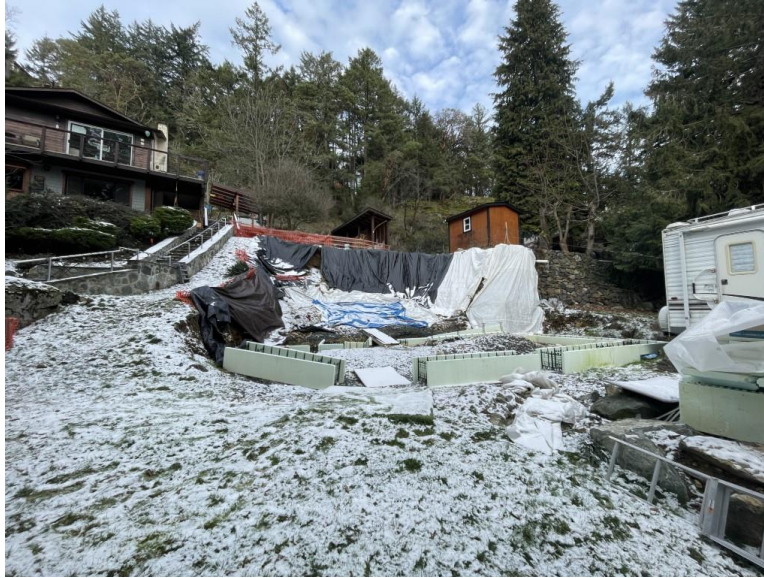
Photo 1. View looking west at the excavation of the proposed pool and structure. January 16,2024

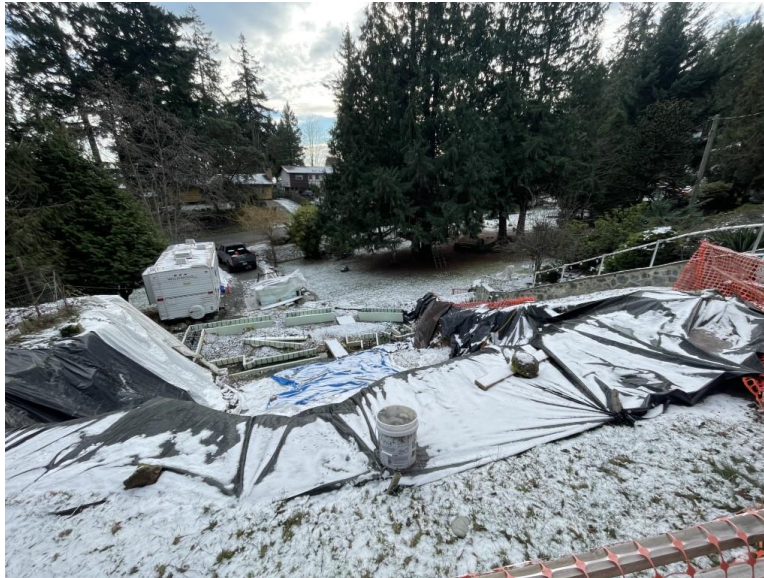
Photo 2. View looking east at the excavation of the proposed pool and structure. January 16,2024

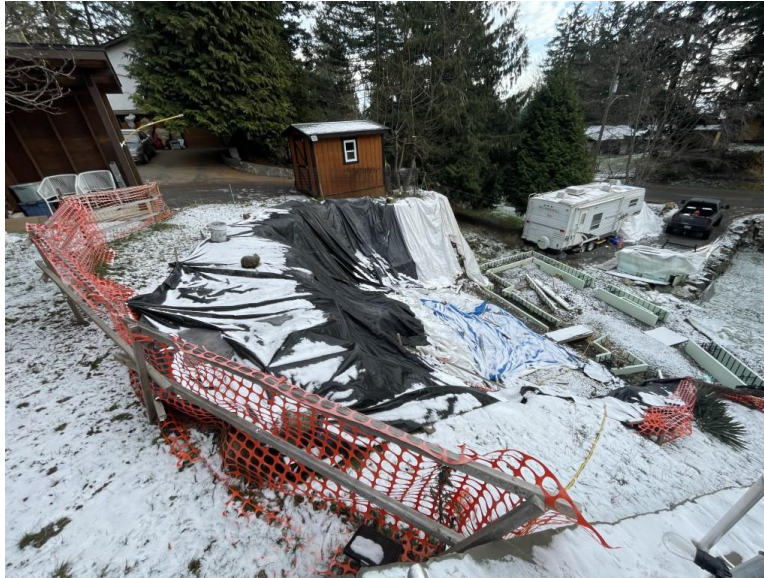
Photo 3. View looking north. All exposed soils have been covered with polyurethane plastic that are subject to rainfall or snow, no evidence of runoff or erosion. January 16,2024

Upon completion of the structure, Corvidae recommends the site be seeded with a fall rye grass seed mix for all exposed soils to ensure ecological compatibility and stabilization.

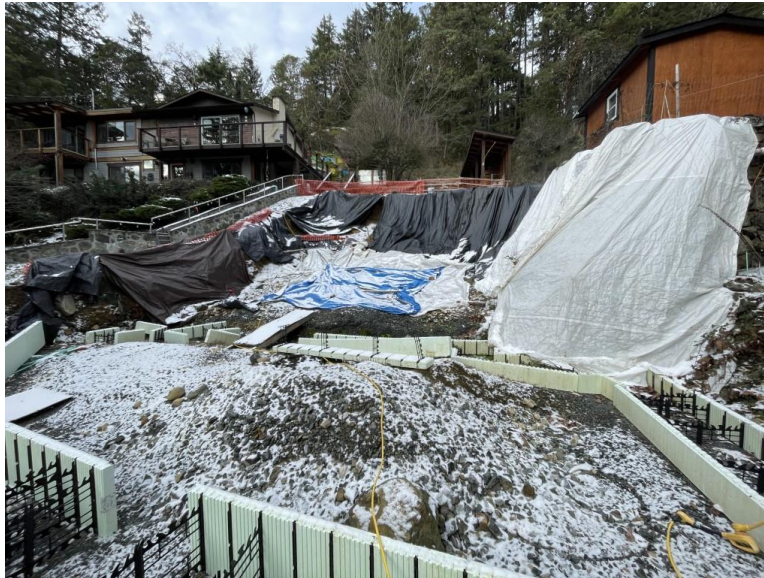
Photo 4. View looking west. Gravel has been placed for the foundation walls. There is no evidence of erosion or impacts being made to the surrounding environment. January 16,2024

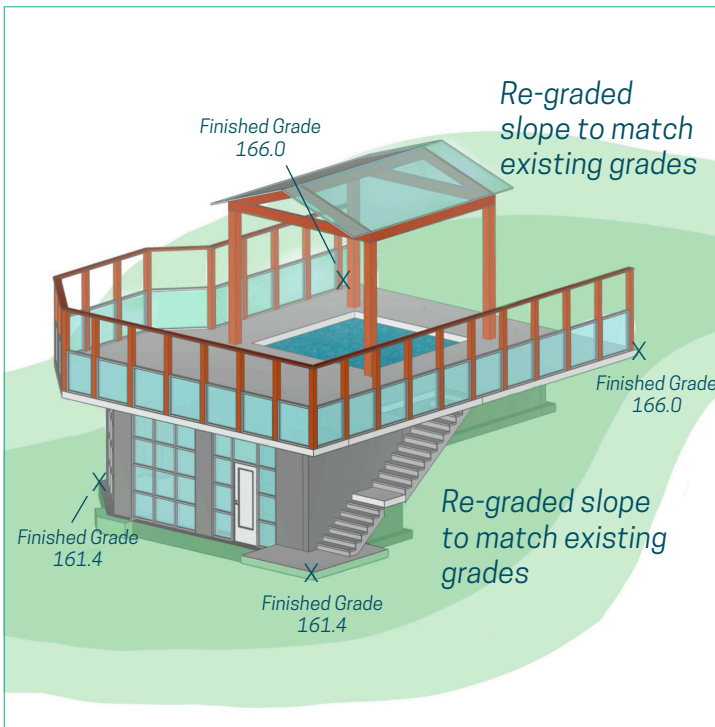
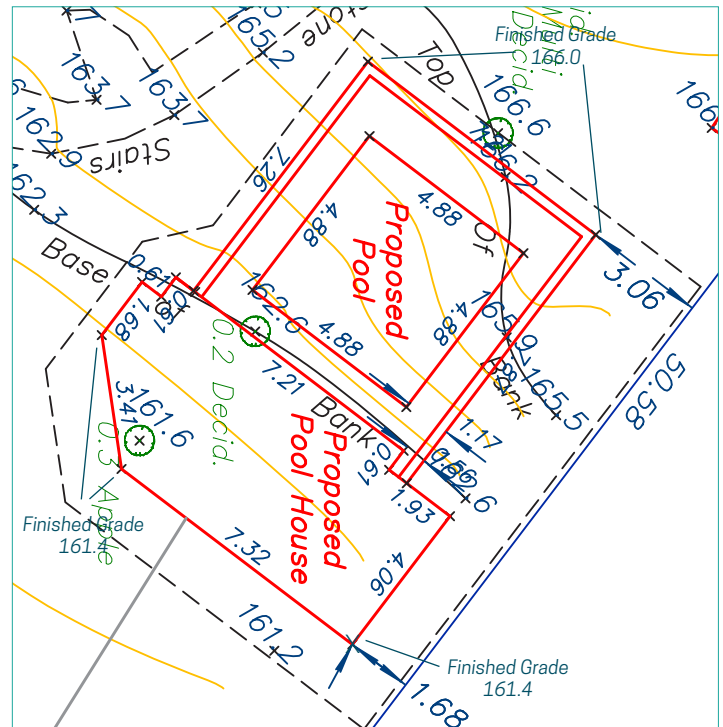
The site will be re-graded back to the original slope and grades on the east, north, and west sides of the subject area. The south side grade has not be altered. See plans and diagrams below.

Illustration of site grading, post-construction to maintain existing slope

Site plan showing existing grades to be maintained post-construction
