## CITY OF COLWOOD

3300 Wishart Road | Colwood | BC V9C 1R1 | 250 478 5999 planning@colwood.ca | www.colwood.ca

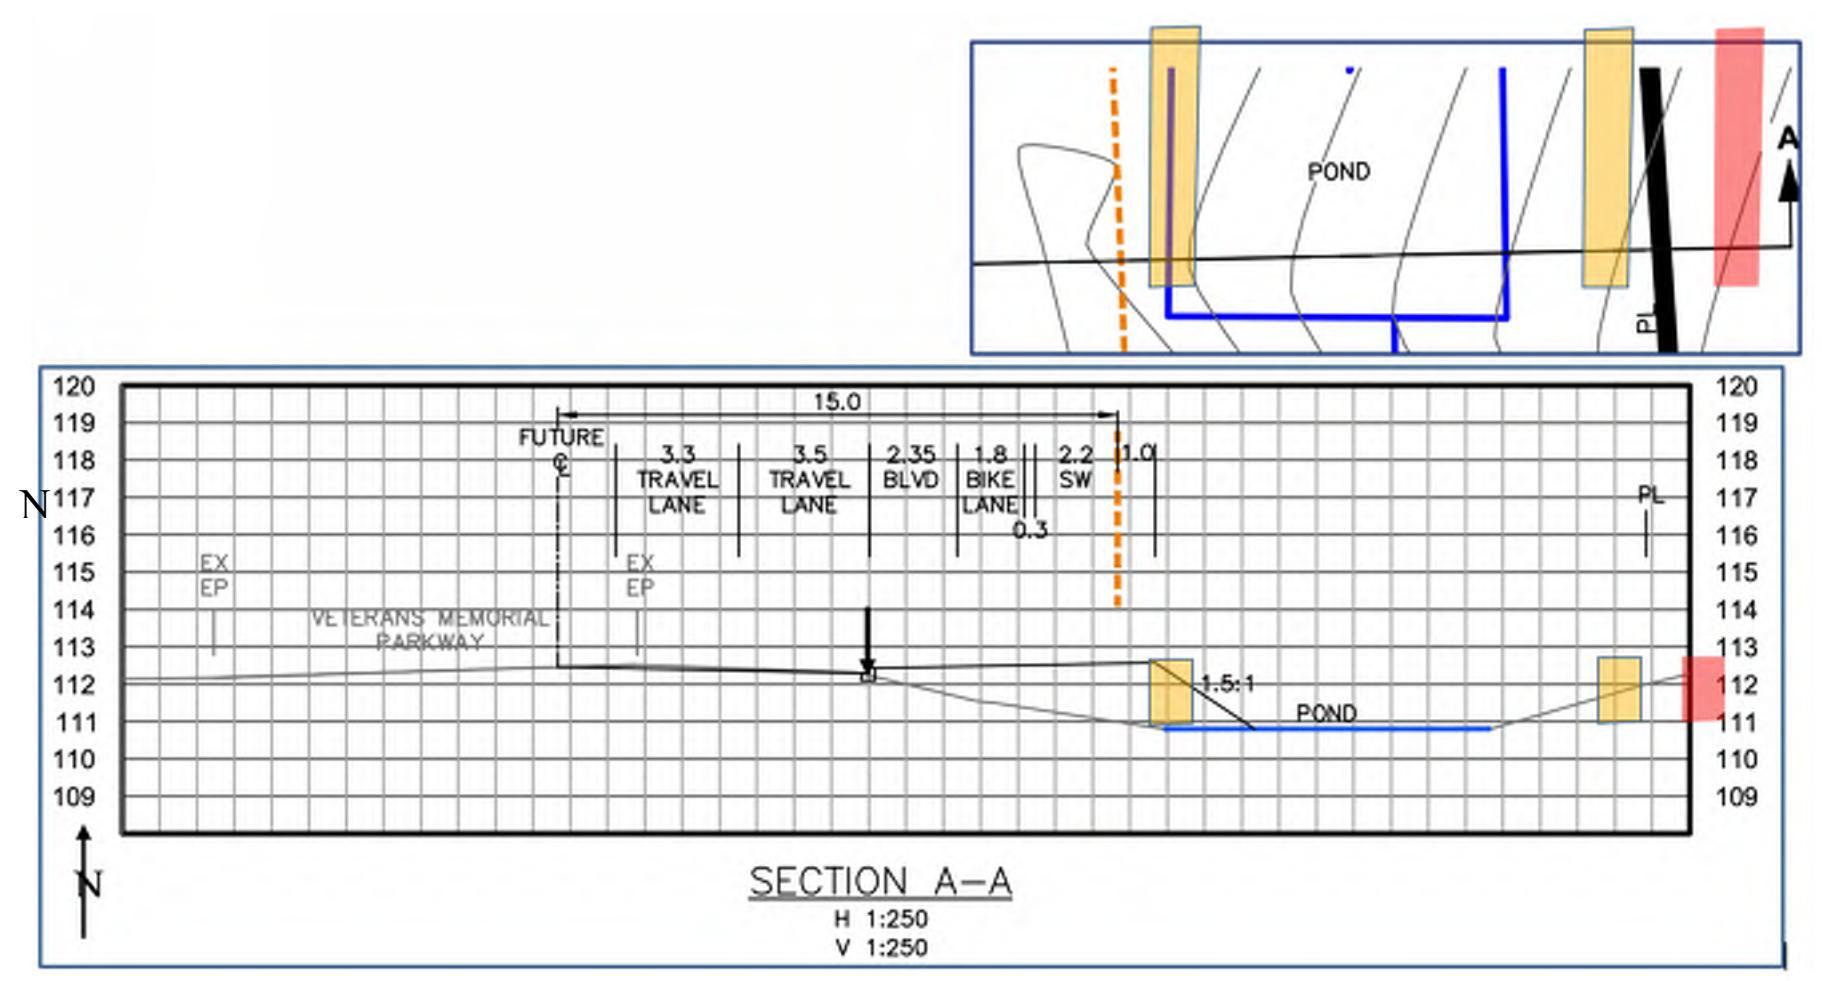
Figure 16. Coloured rectangles = Flex MSE retaining walls (1.0m wide X 2.0m Height). Current western sloping side wall of pond could be replaced with a vertical Flex MSE retaining wall, 7.5m west of existing SW Pond top-of-bank (black arrow); the eastern sloping side wall of pond could be replaced with a vertical Flex MSE, either within the VMP ROW (orange rectangle) or moved east on private land (red rectangle). If a "no-net-loss' of SW pond volume is required, the red Flex MSE vertical wall would be moved east to maintain the historical pond volume. Insert, upper right, shows the vertical Flex MSE retaining walls in Plan View.

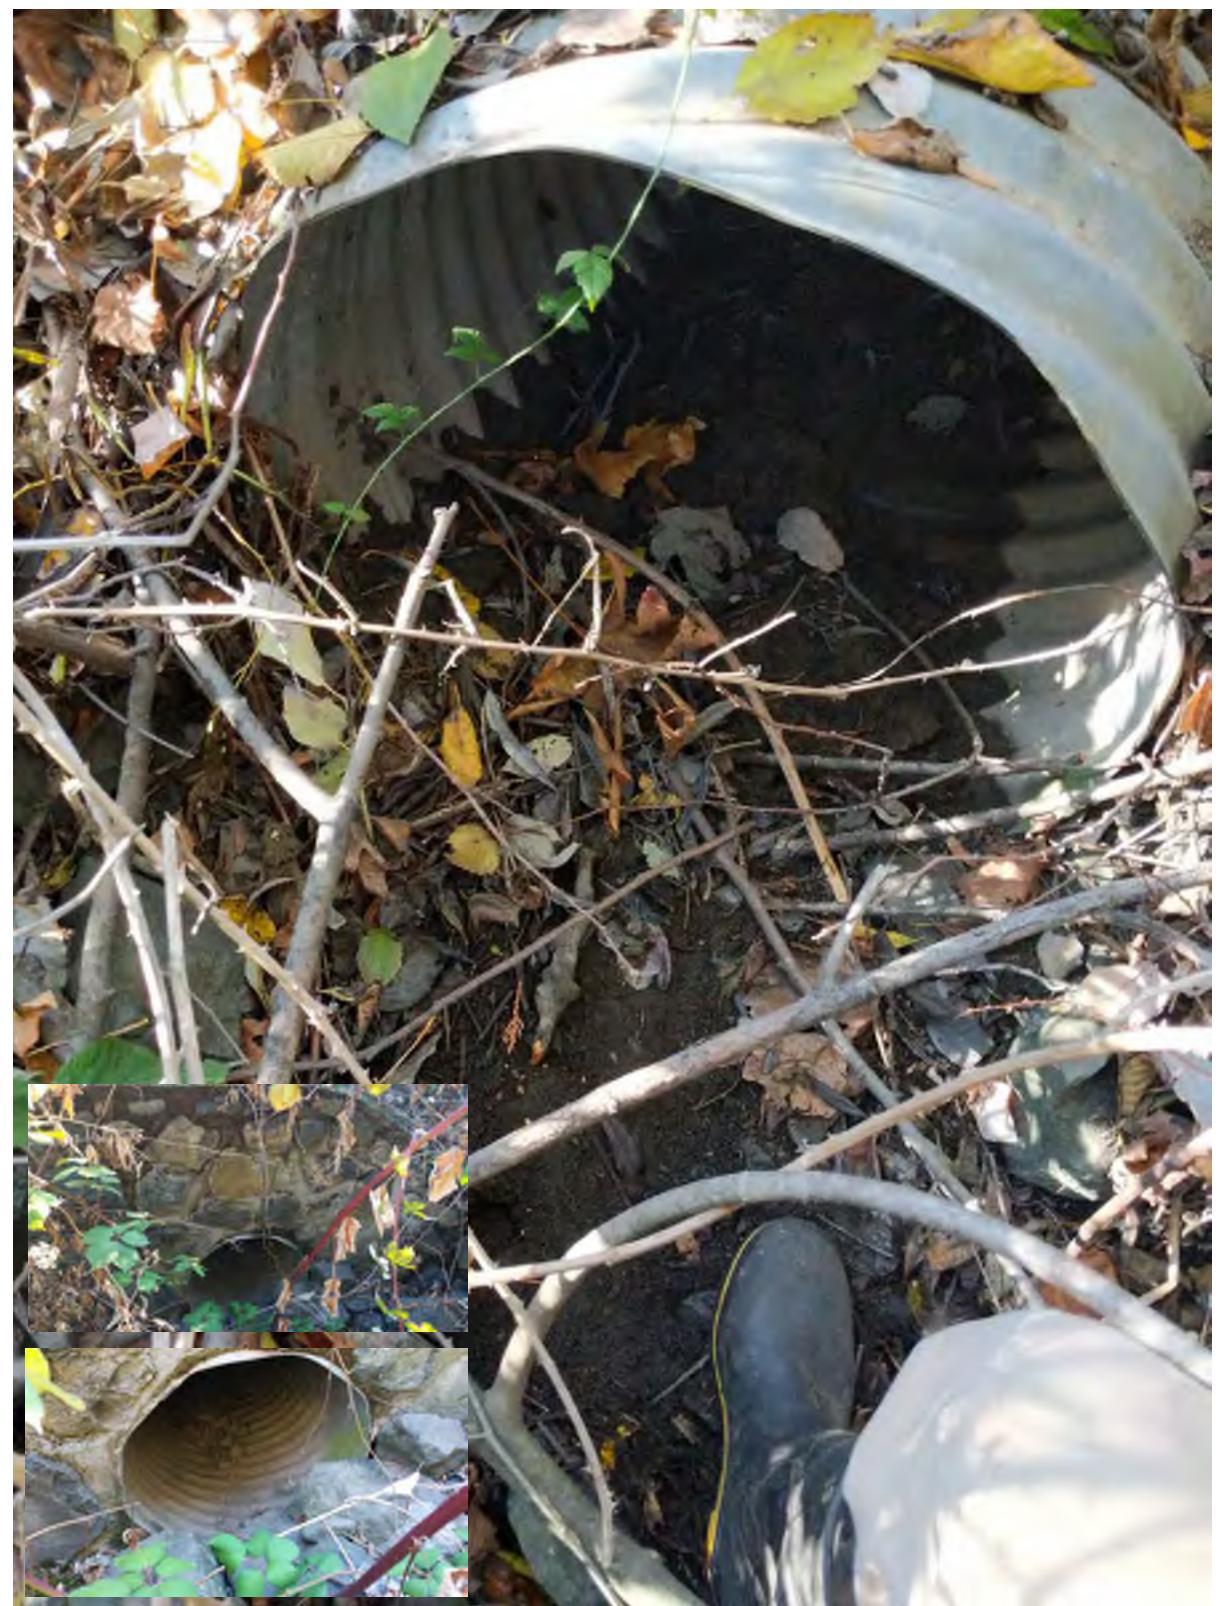
Figure 9. Outlet of the drainage culvert under VMP (Figure 8) showing the blocked outlet consisting of a soil berm which prevents the free flow of periodic, low runoff volumes routed from the west side of VMP into a treatment pond on the east side of VMP. Image inserts of inlet of the culvert, noting that there is no rusted water line or evidence of regular stormwater flow.

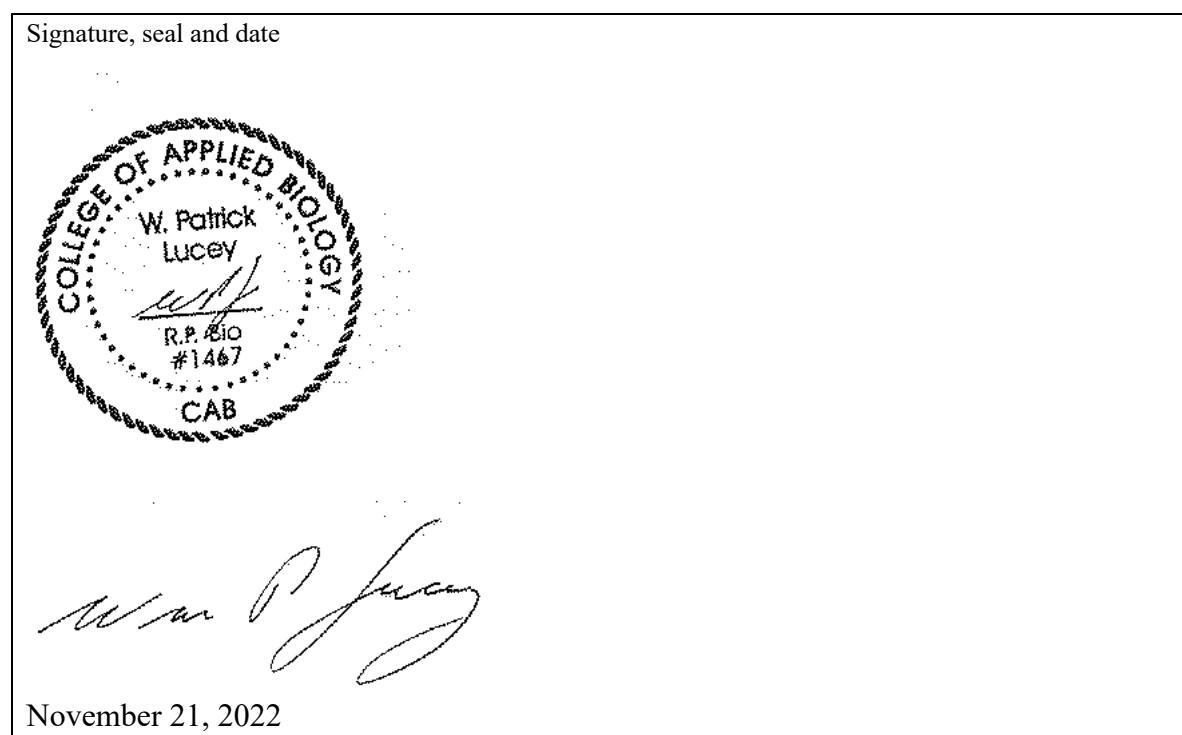
\*HADD – harmful alteration, disruption or destruction of natural features, functions and conditions that support fish life processes

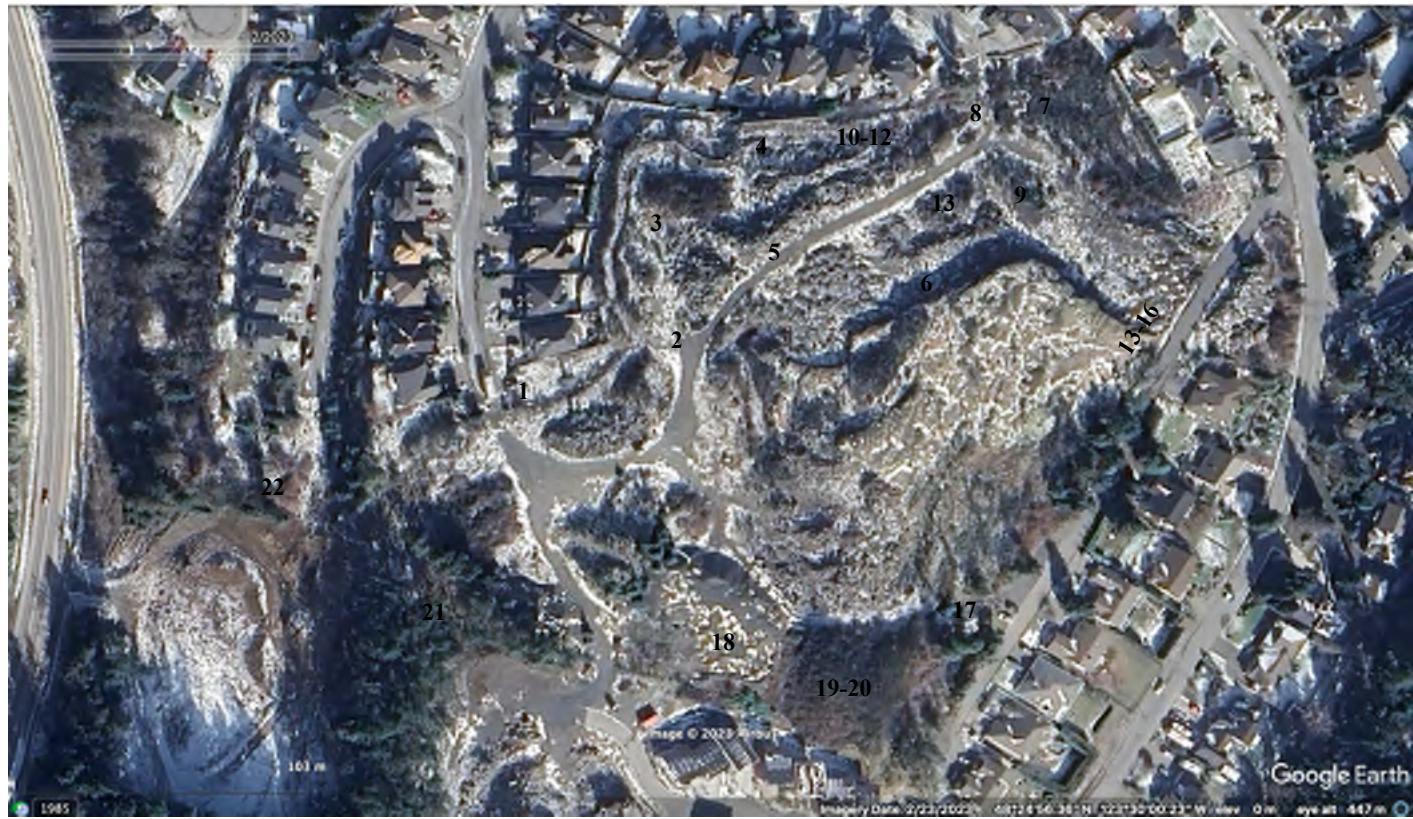
Photo 1. Numbers = locations of photographs shown below. The property was walked in a clockwise manner, following the photopoint location numbers, in chronological order.

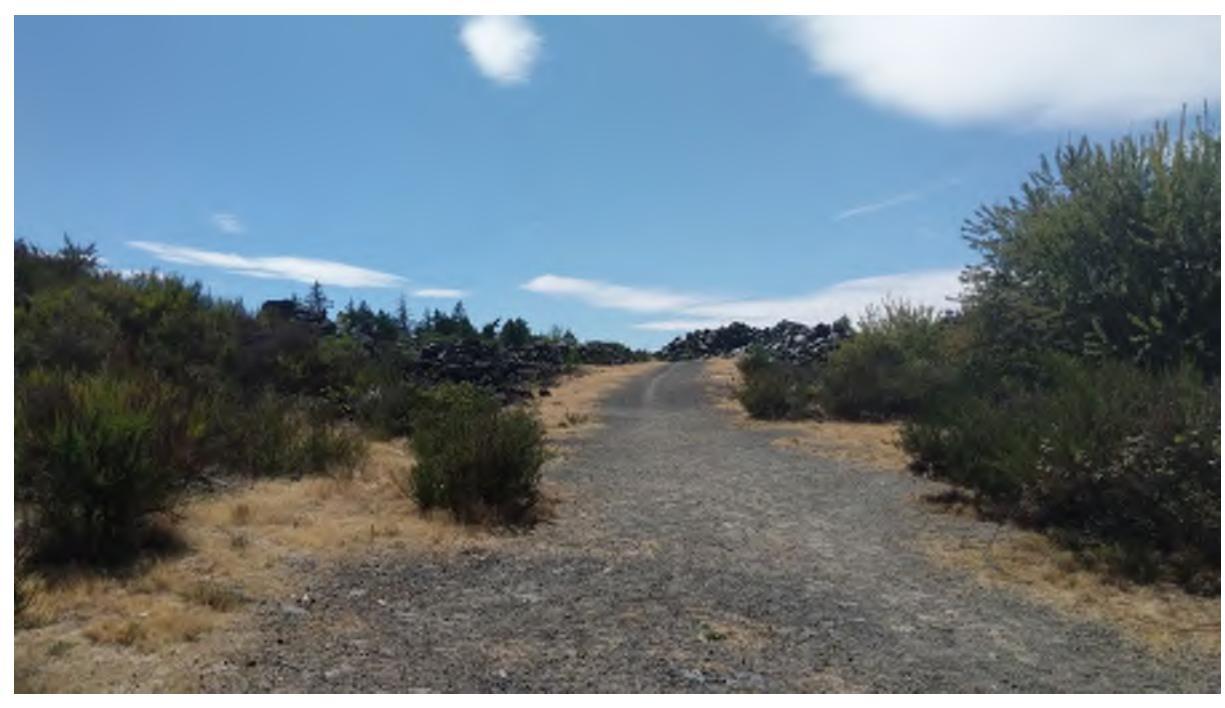
Photo 5. Looking southwest along an internal construction road. Note the dominance of invasive species and the dry conditions of the agronomic grasses.

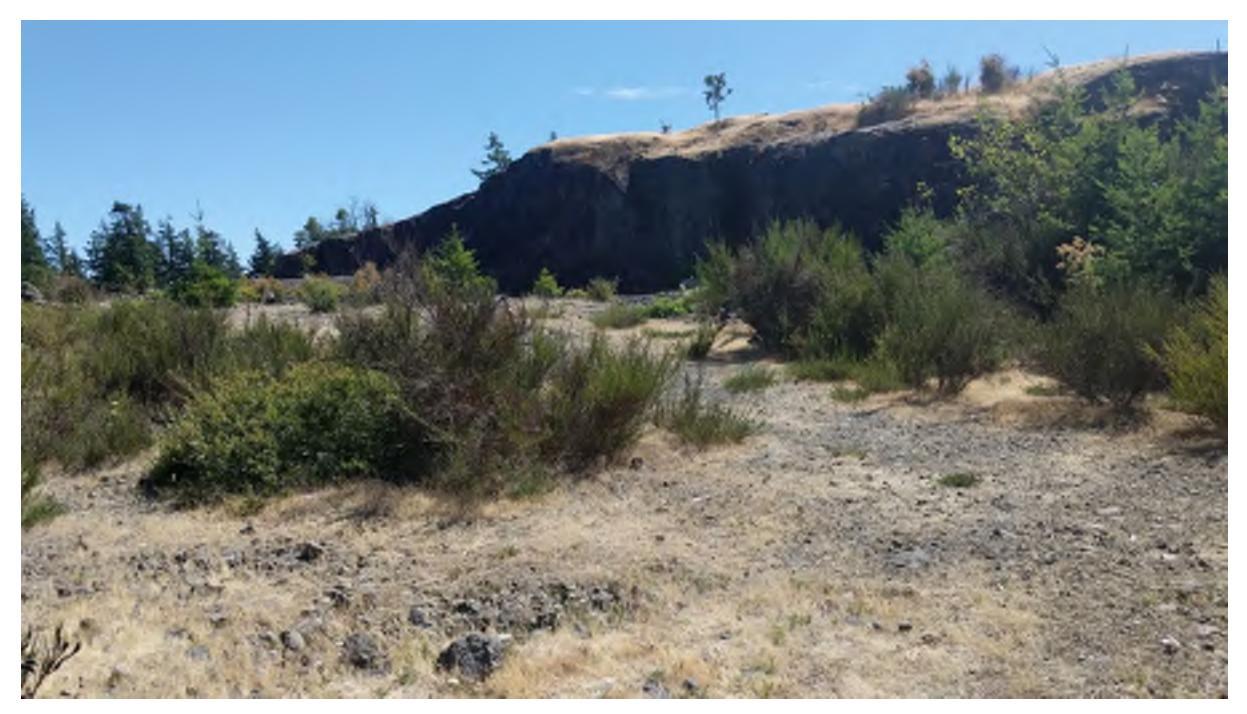
Photo 6. Looking southeast across the terrace lying north of the bedrock peak elevation. The vegetation is sparse, dominated by invasives, with a few small conifers visible. Note the absence of blackberry in this area, likely due to the absence of soil moisture.

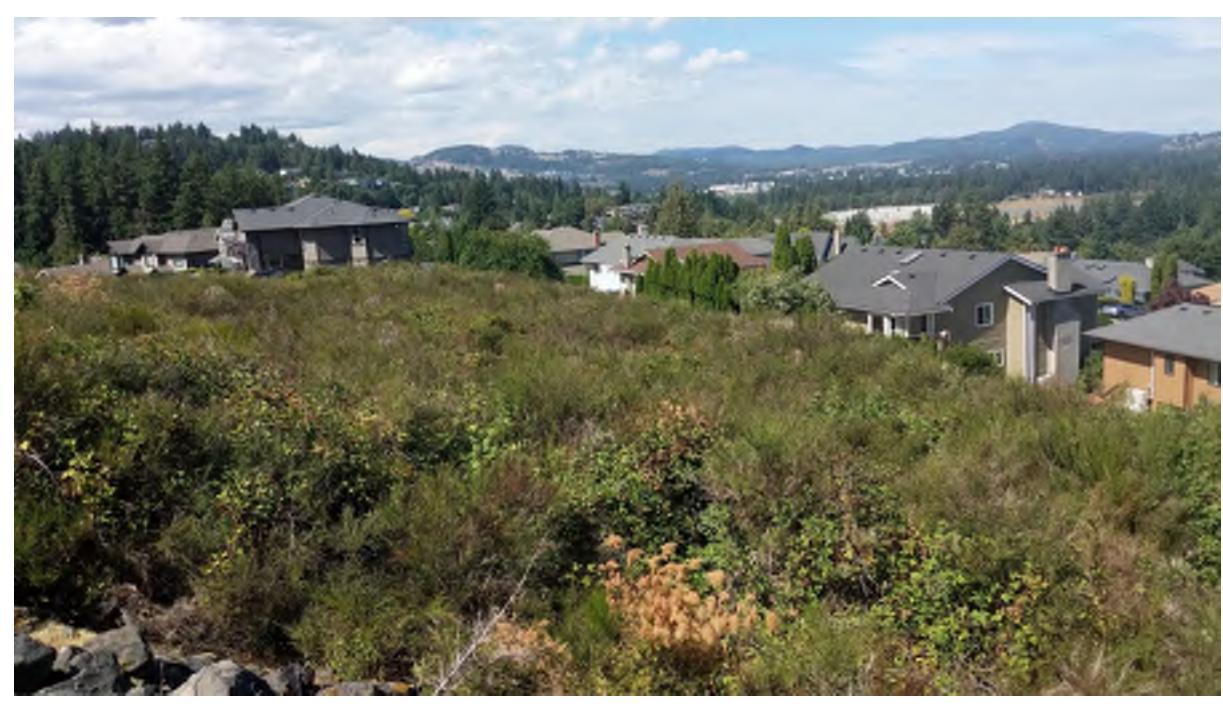
Photo 7. Looking northeast across the broom dominated landscape.

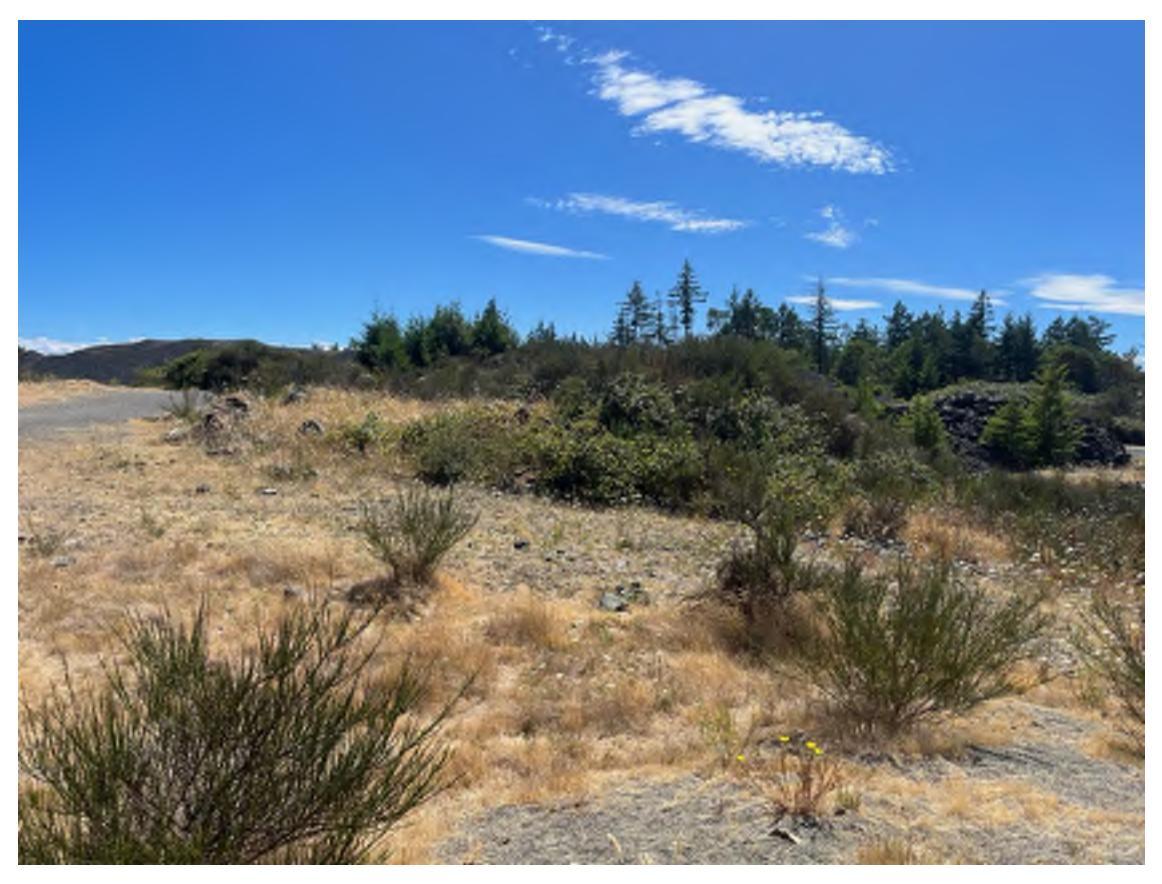
Photo 9. Looking southeast - invasives dominate the sparse plant community. Soil moisture is absent for most of the year resulting in poor plant cover and a thin organic covering the bedrock.

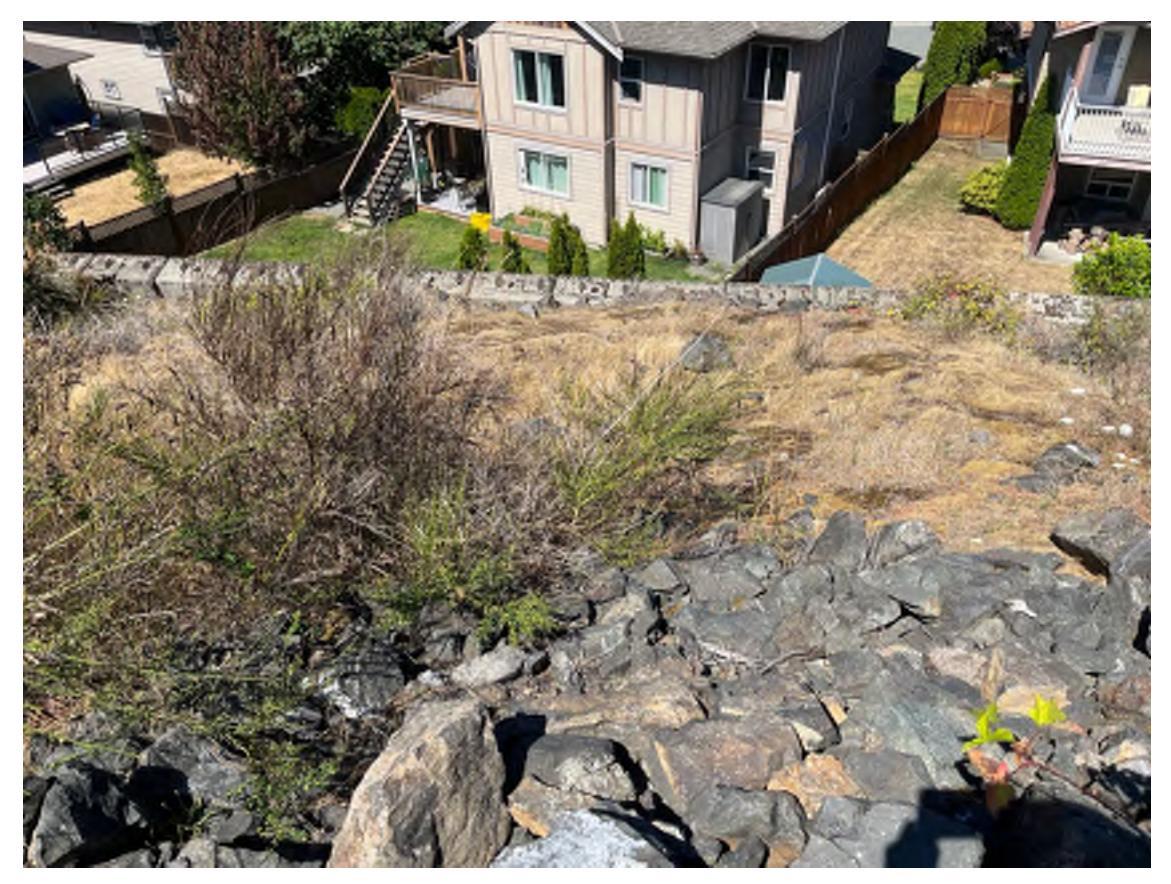
Photo 10. Looking north down slope to homes on Cottyn Way. Note sparse cover and large blast rock.

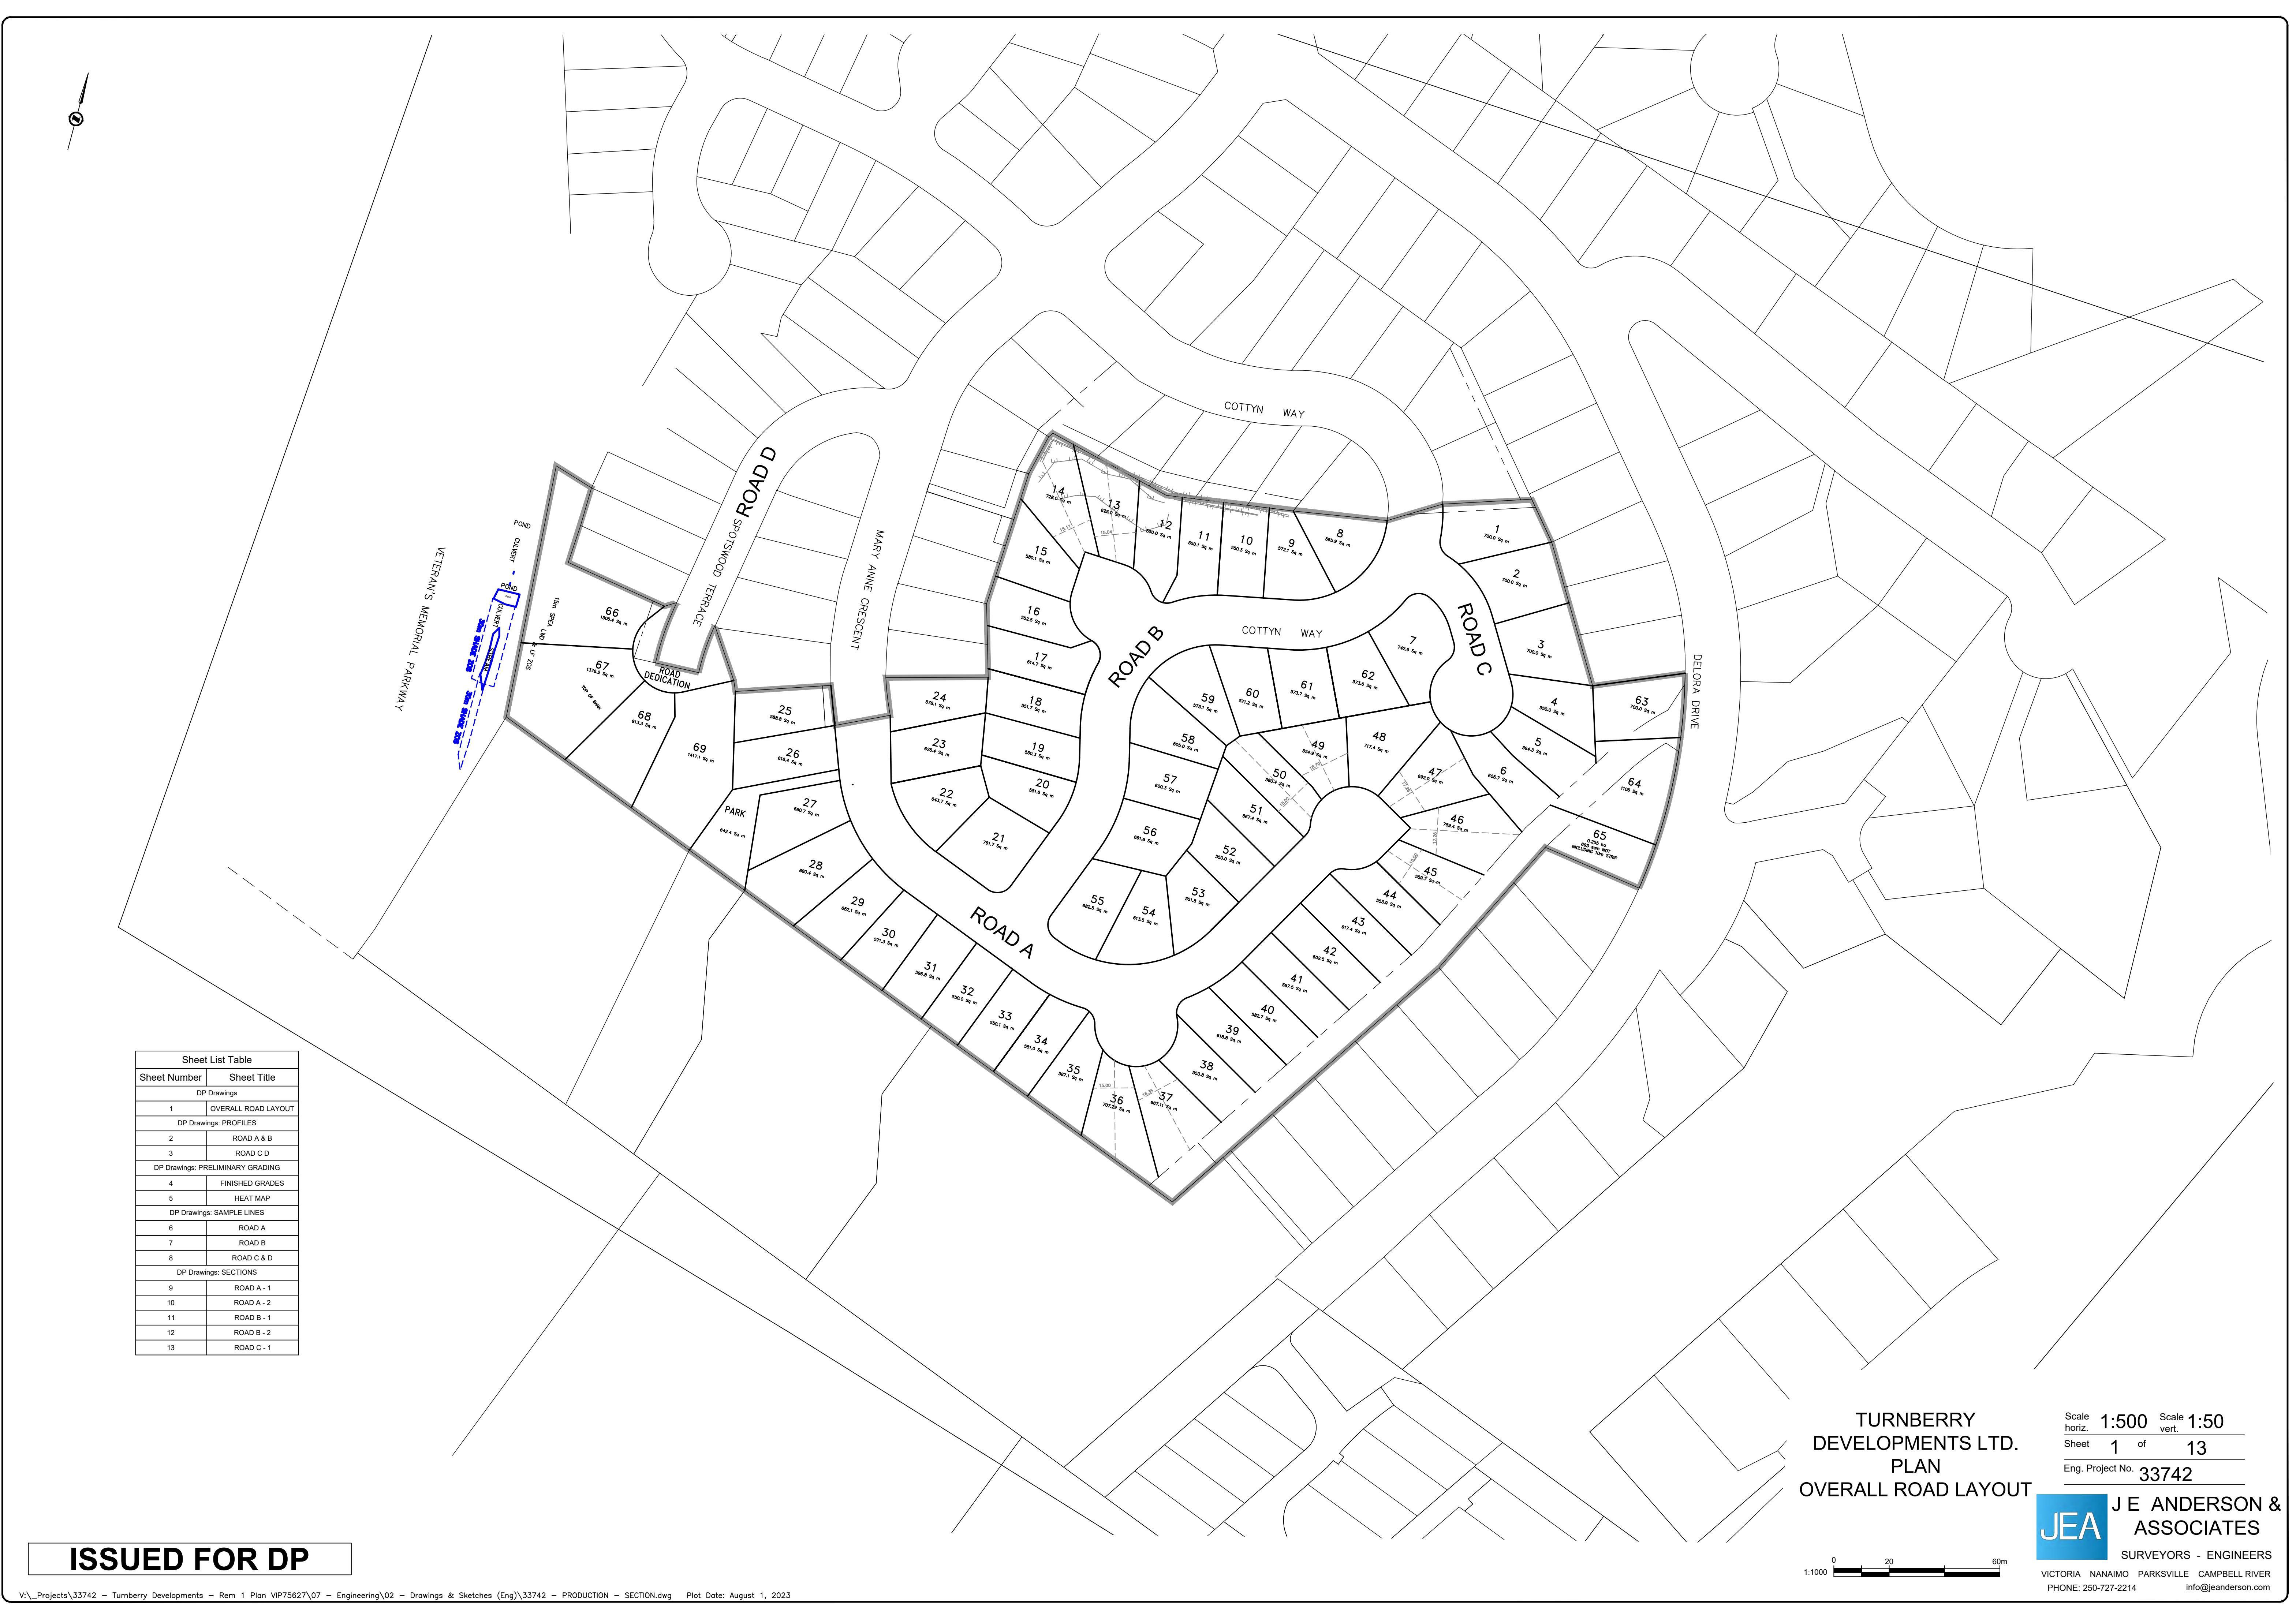
cc: Danny Carrier - danrearrier@gmail.com
