An Investigation into Erosion and Armouring Effects on the Coburg Peninsula at the Esquimalt Lagoon, Colwood BC

Bryce O'Connor, Naomi Muller & Jessica Perkins

University of Victoria

Geography 476

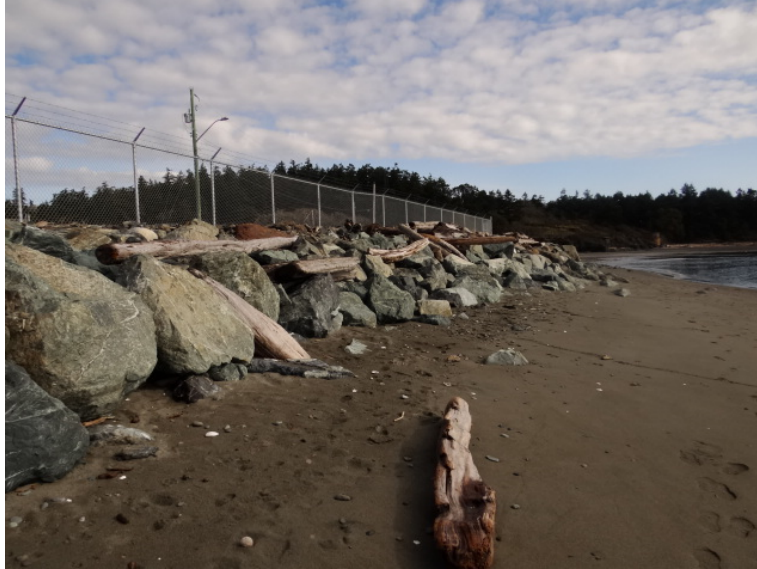
Figure 5. Rip-rap added to the northern end of the peninsula as a mitigation method

Rip-rap is an anthropogenic structure constructed in an attempt to mitigate erosion. Rip-rap was put in place on the seaward side of the northern tip of the Peninsula (see Figure 4) to protect the DND Ranger Station from wave action and erosion (Seabulk Systems Inc., 2008, p. 3). The station was removed on Friday September 13, 2013 due to seawater

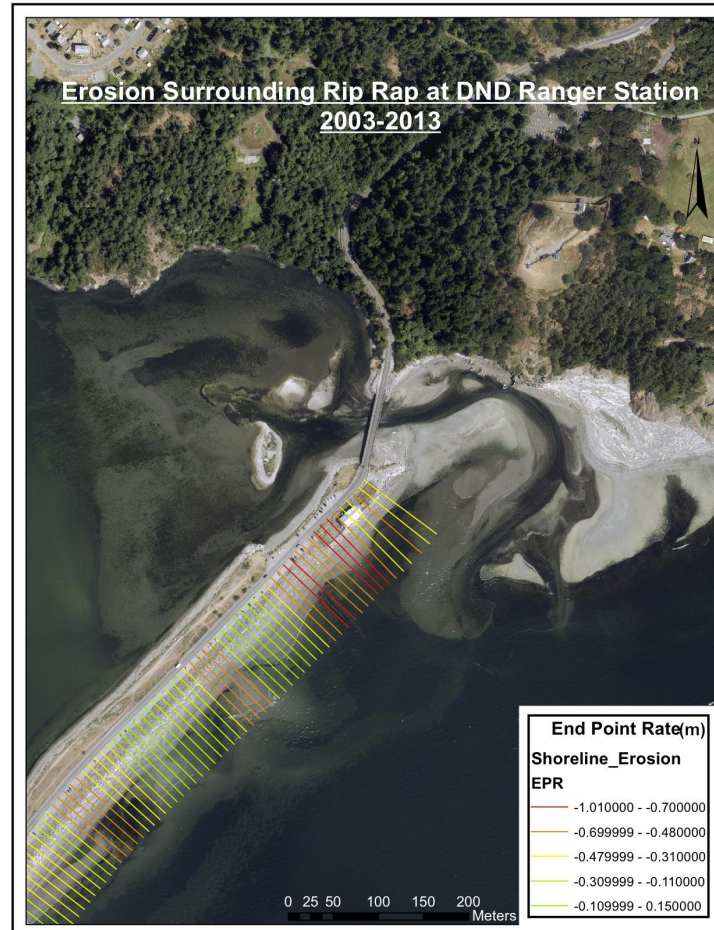
Figure 8. Northern tip of Coburg Peninsula.

Figure 8 highlights the increased erosion around the rip-rap during 2003 to 2013. The rip-rap was installed to protect the Ranger DND station; however, this strategy was unsuccessful as the station was removed after being damaged by wave action. Hard structures used to protect shorelines often concentrate erosion on other portions of the shoreline. Observation of the beach face during the winter of 2014 showed a steep, thin beach with waves often running right into the rip-rap. This suggests rip-rap has accelerated the process of beach thinning and caused increased erosion.

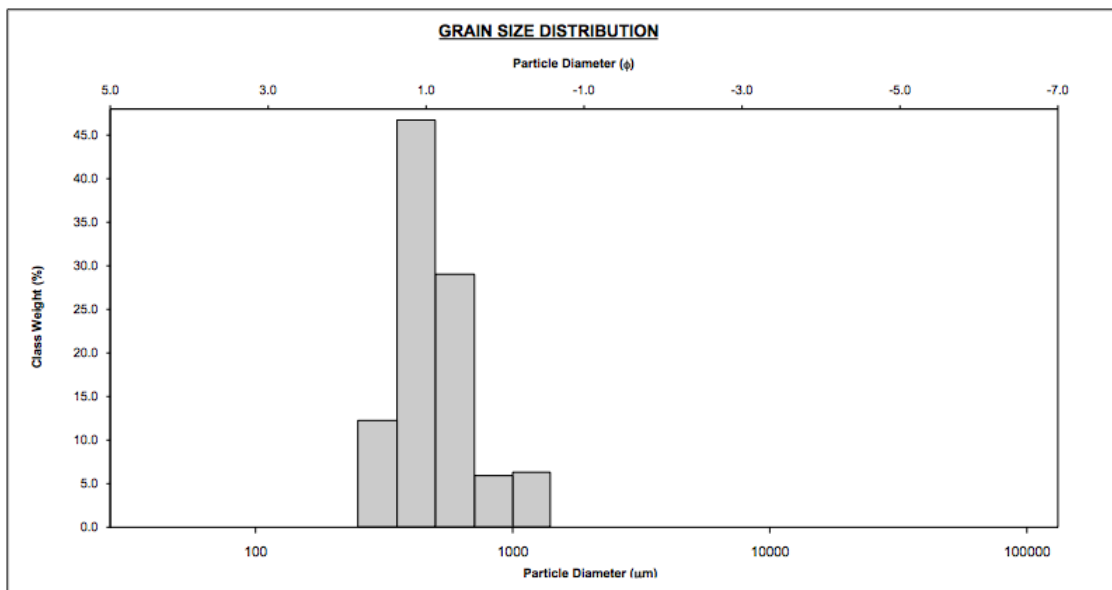
Figure 13. Grain Size Distribution at Site 4.

The distribution of grain size for each site indicate which grain sizes were most abundant in the sample and which were less so. These distributions are shown in Figures 10 to 13.
