# Public Input Binder

The general purpose of proposed “**Colwood Land Use Bylaw No. 151, 1989, Amendment No. 231 (HAH1-3415 Fulton Road), Bylaw No. 2105, 2026**” is to rezone from Residential 1 (R1) Zone to Hillside Attached Housing 1 (HAH1) Zone to permit a townhouse development on the property

**To:** CAO – Jason Johnson  
**Submitted:**  
**From:** Richard Roy, Senior Planner  
**RE:** RZ000027 - 3415 Fulton Road

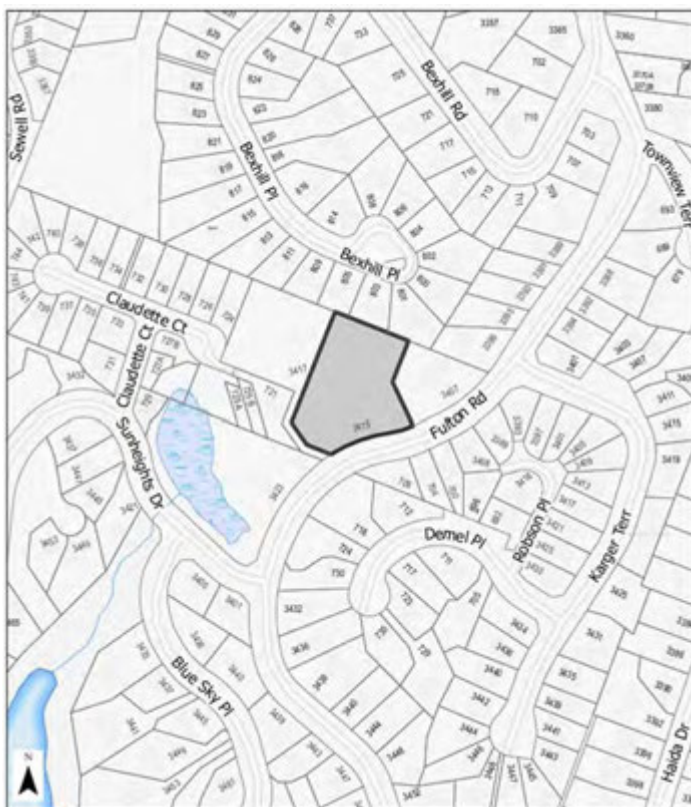
**Figure 1 - Community Context Map**

The subject property is a 5,666.88 m<sup>2</sup> (1.4 acre) parcel located in the Triangle Mountain neighbourhood and fronts onto Fulton Road (**Figure 1**). Access is provided from Fulton Road via an existing steep driveway, that is secured through an easement in favour of the adjacent property at 3407 Fulton Road.

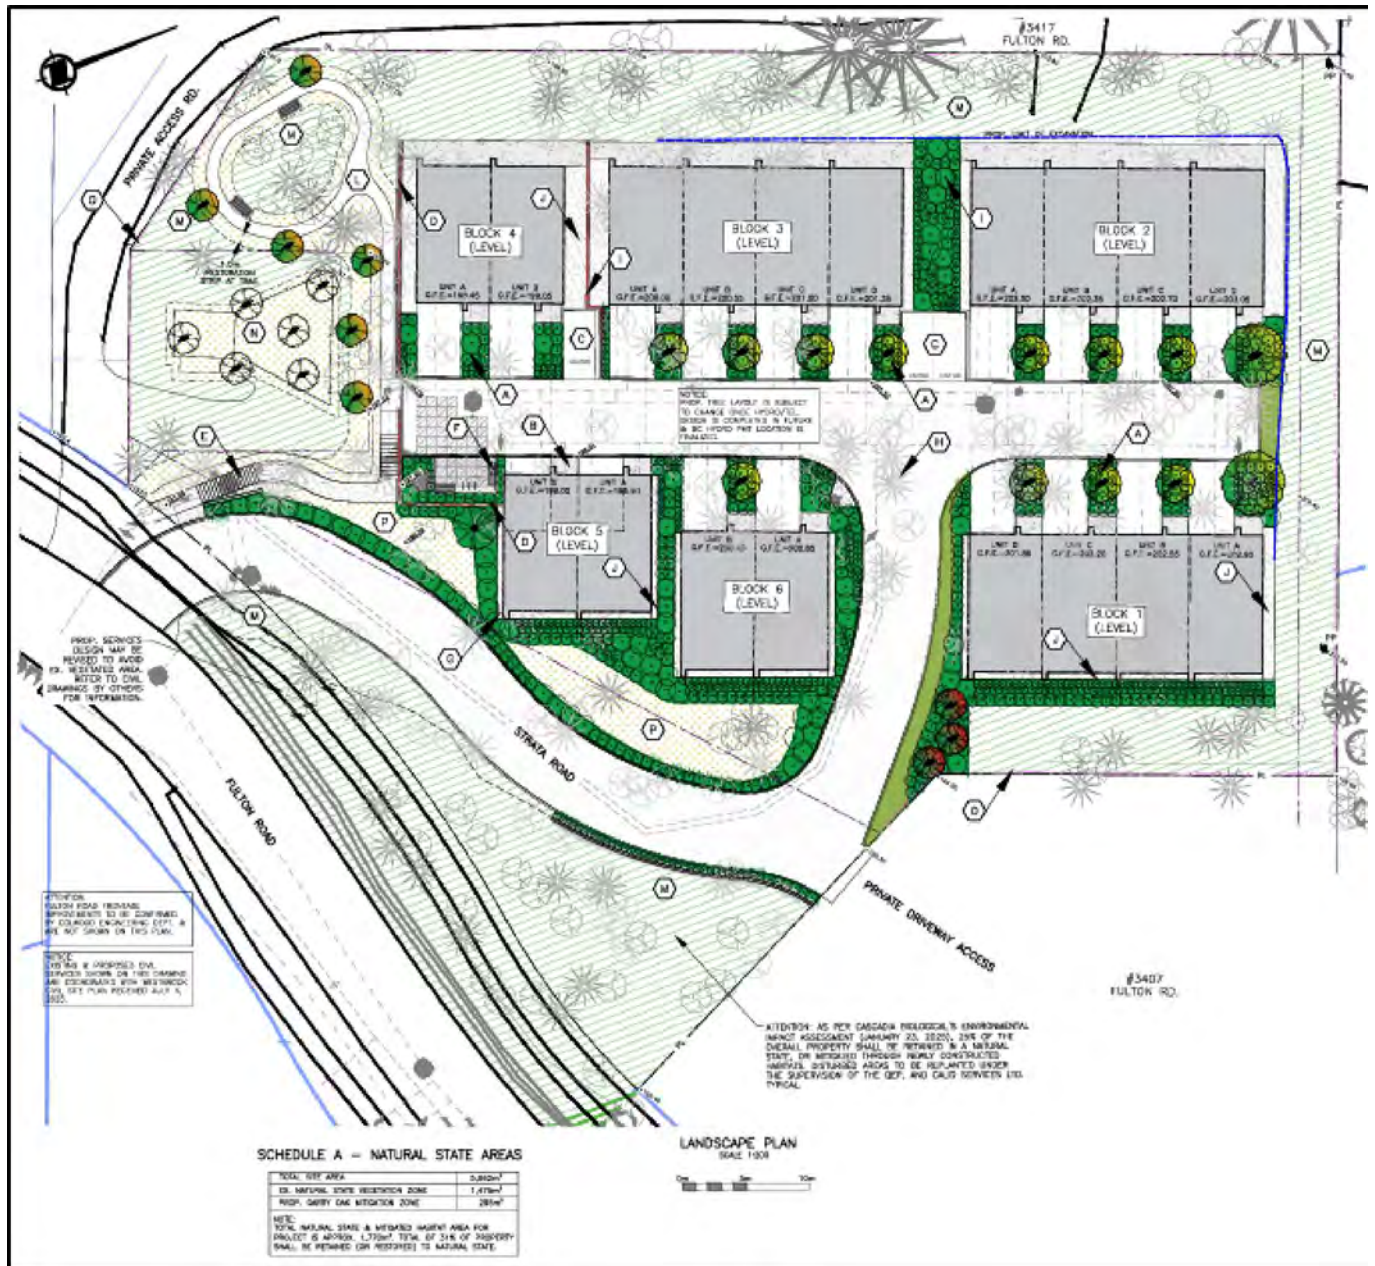
Figure 3 - Site Plan (concept landscape plan)

The 40% open space will support tree retention and replanting, wildlife movement, neighbor screening, and supplemental native landscaping, while also providing visual buffering between the proposed development and adjacent residential properties. Invasive species removal is proposed, and long-term protection and maintenance of both the Site Preservation Covenant and open space will be secured. Collectively, these measures ensure compliance with the OCP's site-adaptive planning principles, protect ecological values on the site, and reinforce the developments compatibility with the surrounding neighborhood.

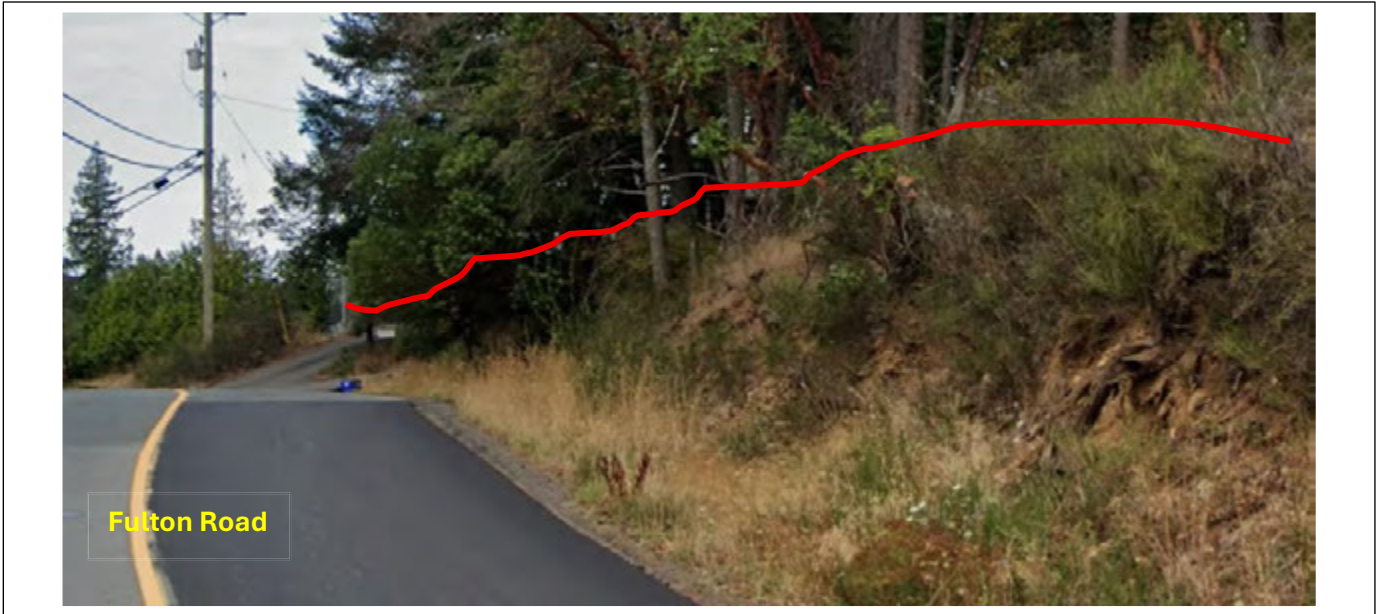
Approx cut line (red)

We also wish to add a Development Variance Permit to this application to remove or modify the frontage improvement requirements along Fulton Road. Please advise if this should be submitted as a separate application. To achieve the bylaw required SSD R19 road width and facilities (sidewalk, boulevard bike lanes etc.) the embankment will be excavated and a retaining wall required to support the property. This will result in the loss of existing trees and cause the proposed strata road grading to deepen to meet the new road grade. This will impact on site trees as well. See image below for an illustration of the cut back extents. A sidewalk exists on the south side of Fulton in this location. Another option might be to provide enhancements here instead.

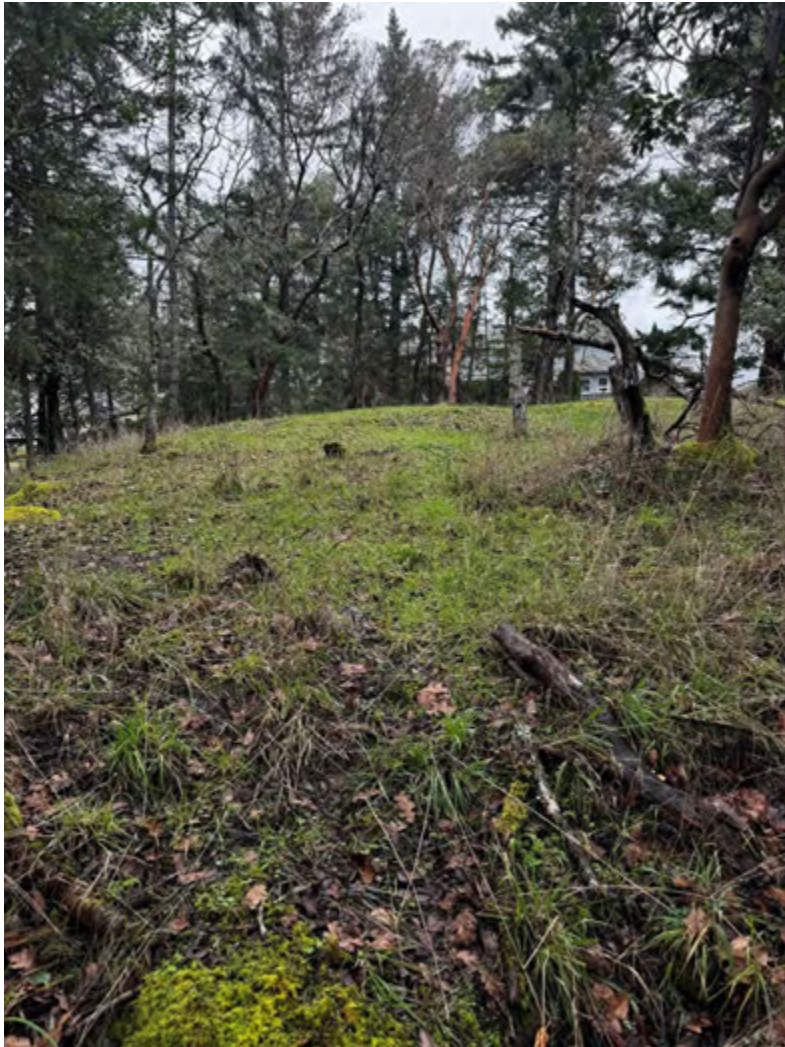
**Plate #1 – Typical view of the stand composition located on the subject property**

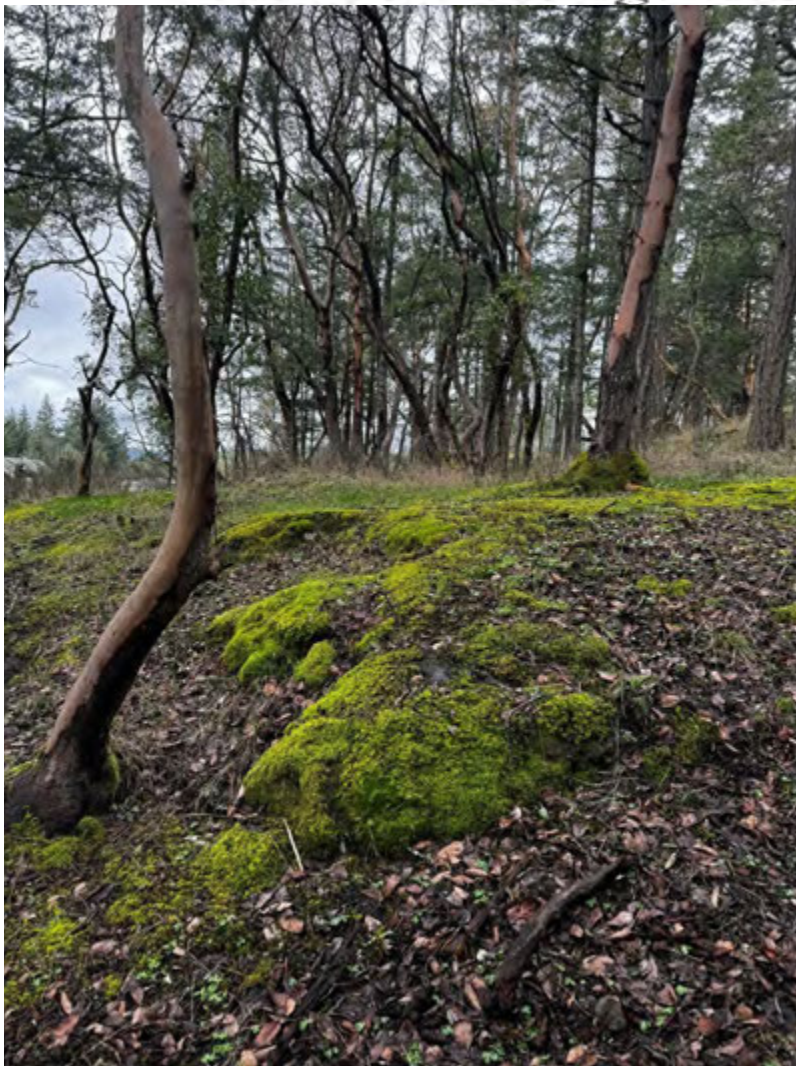
**Plate #2 – Typical view of the Douglas fir/arbutus ecosystem covering the majority of the site**

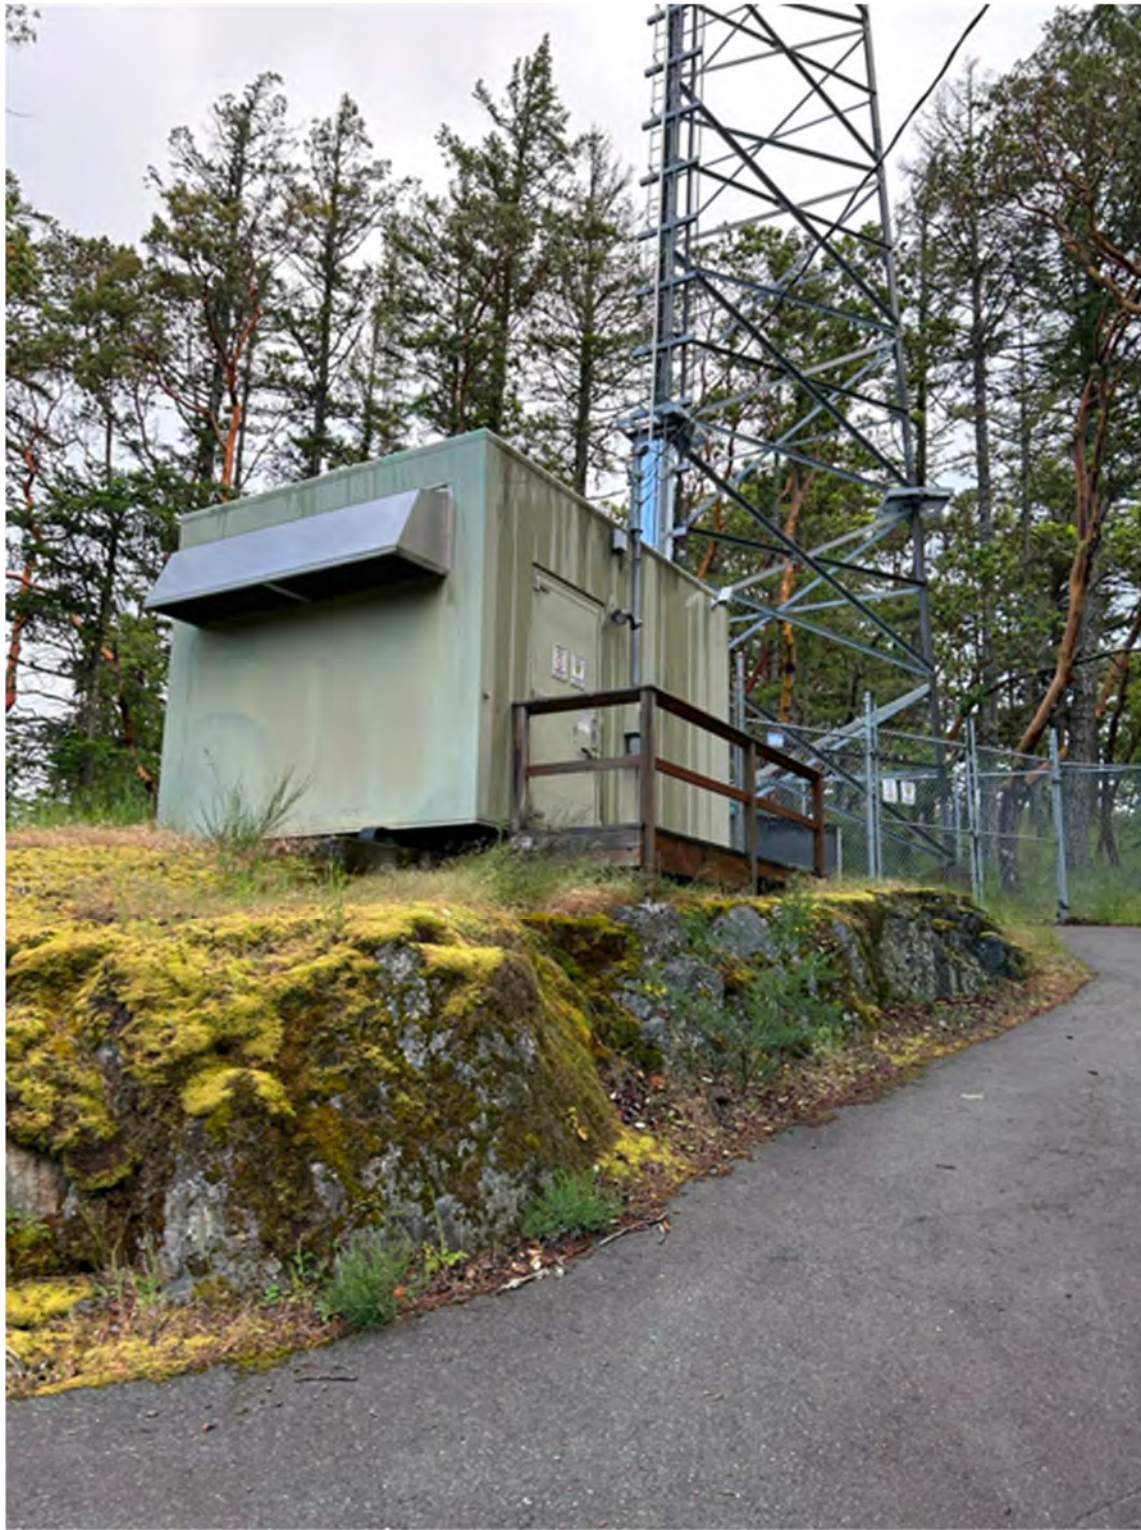
Figure 4- North facing from southwest PL.

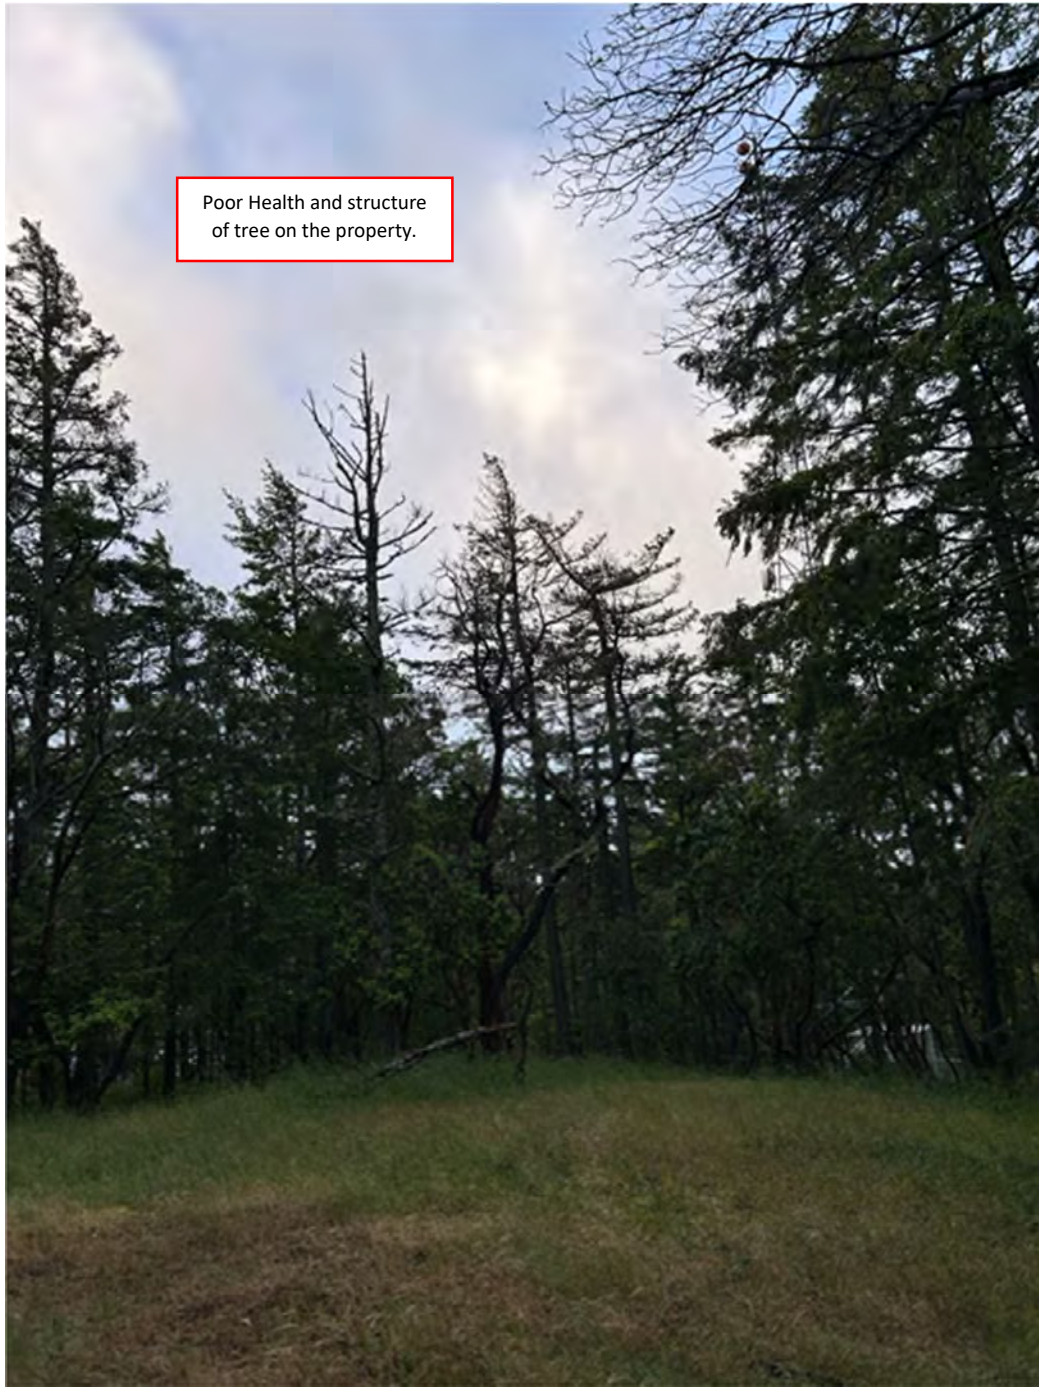
**Figure 6-** Structural condition of many trees similar to the one in this photo.

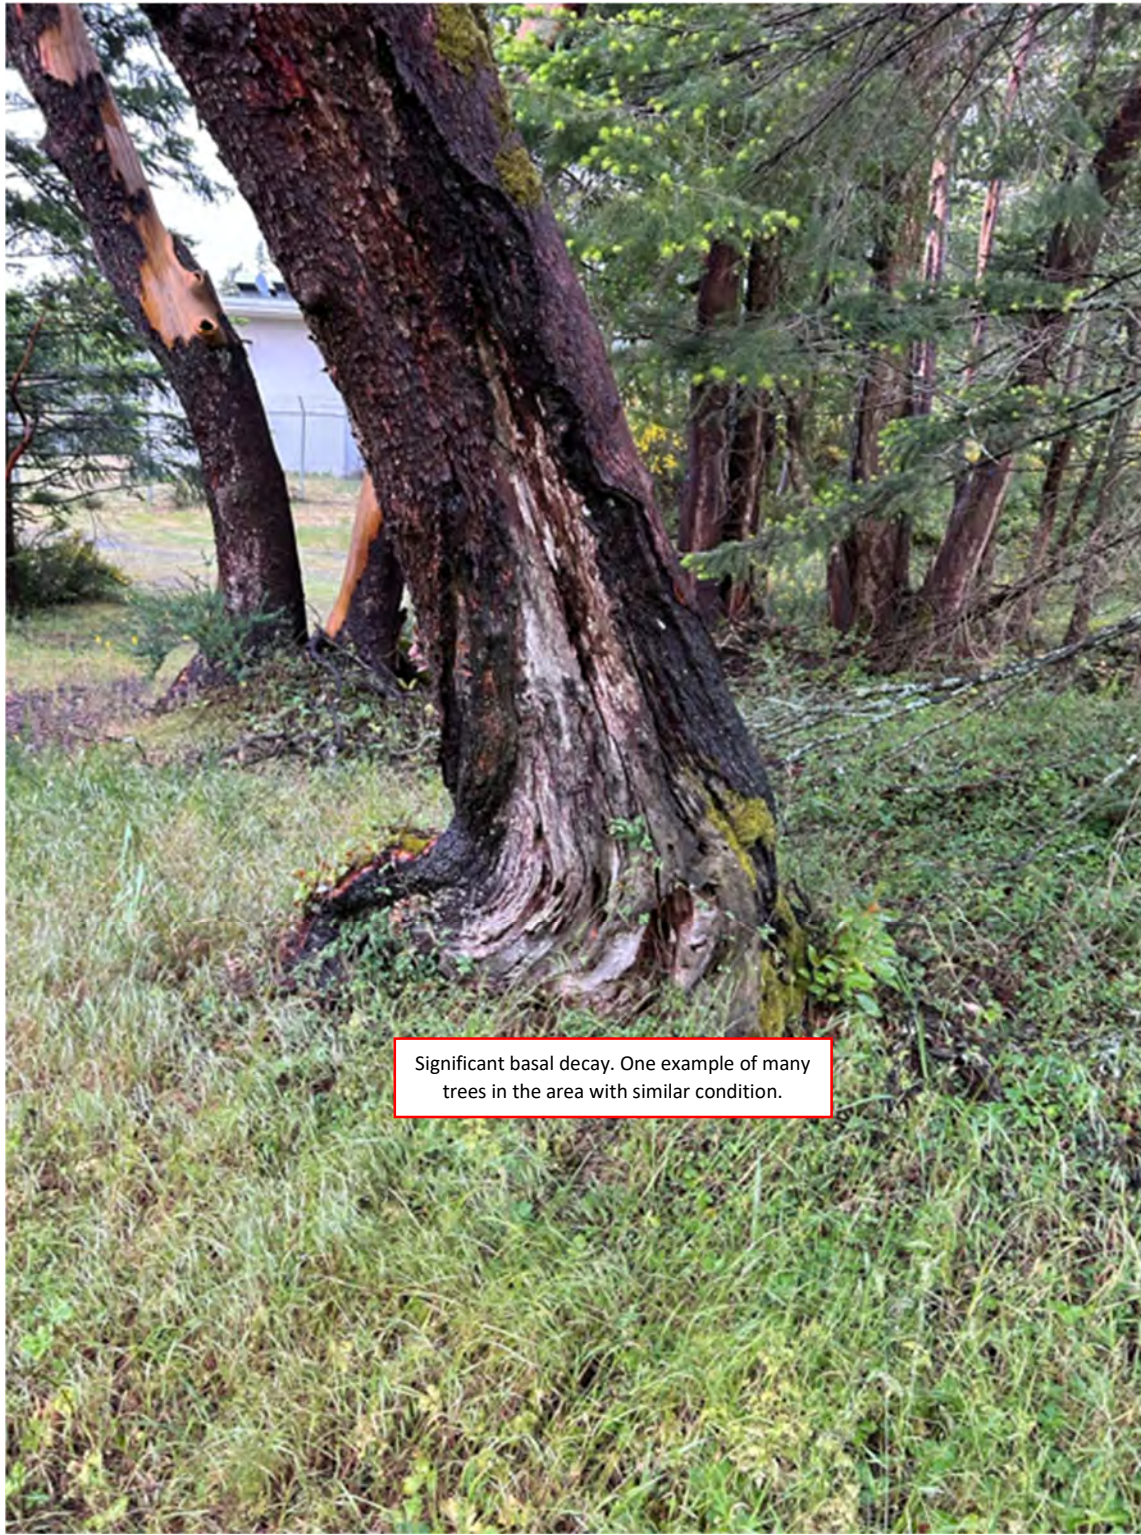
Significant basal decay. One example of many trees in the area with similar condition.

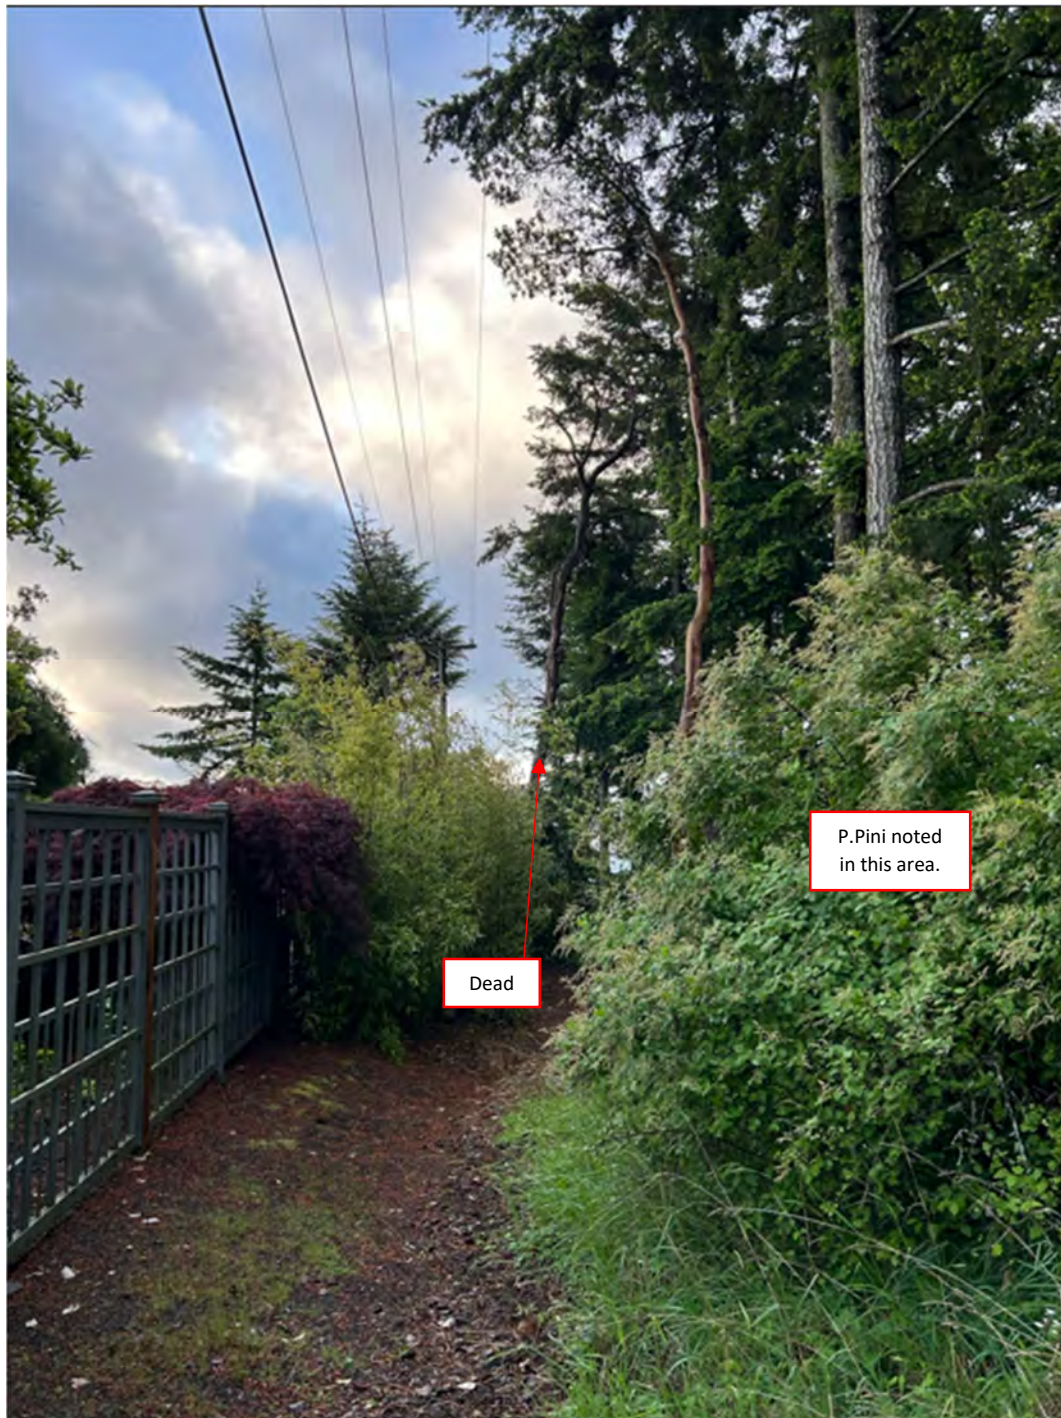
Figure 8- North facing. East-central PL.

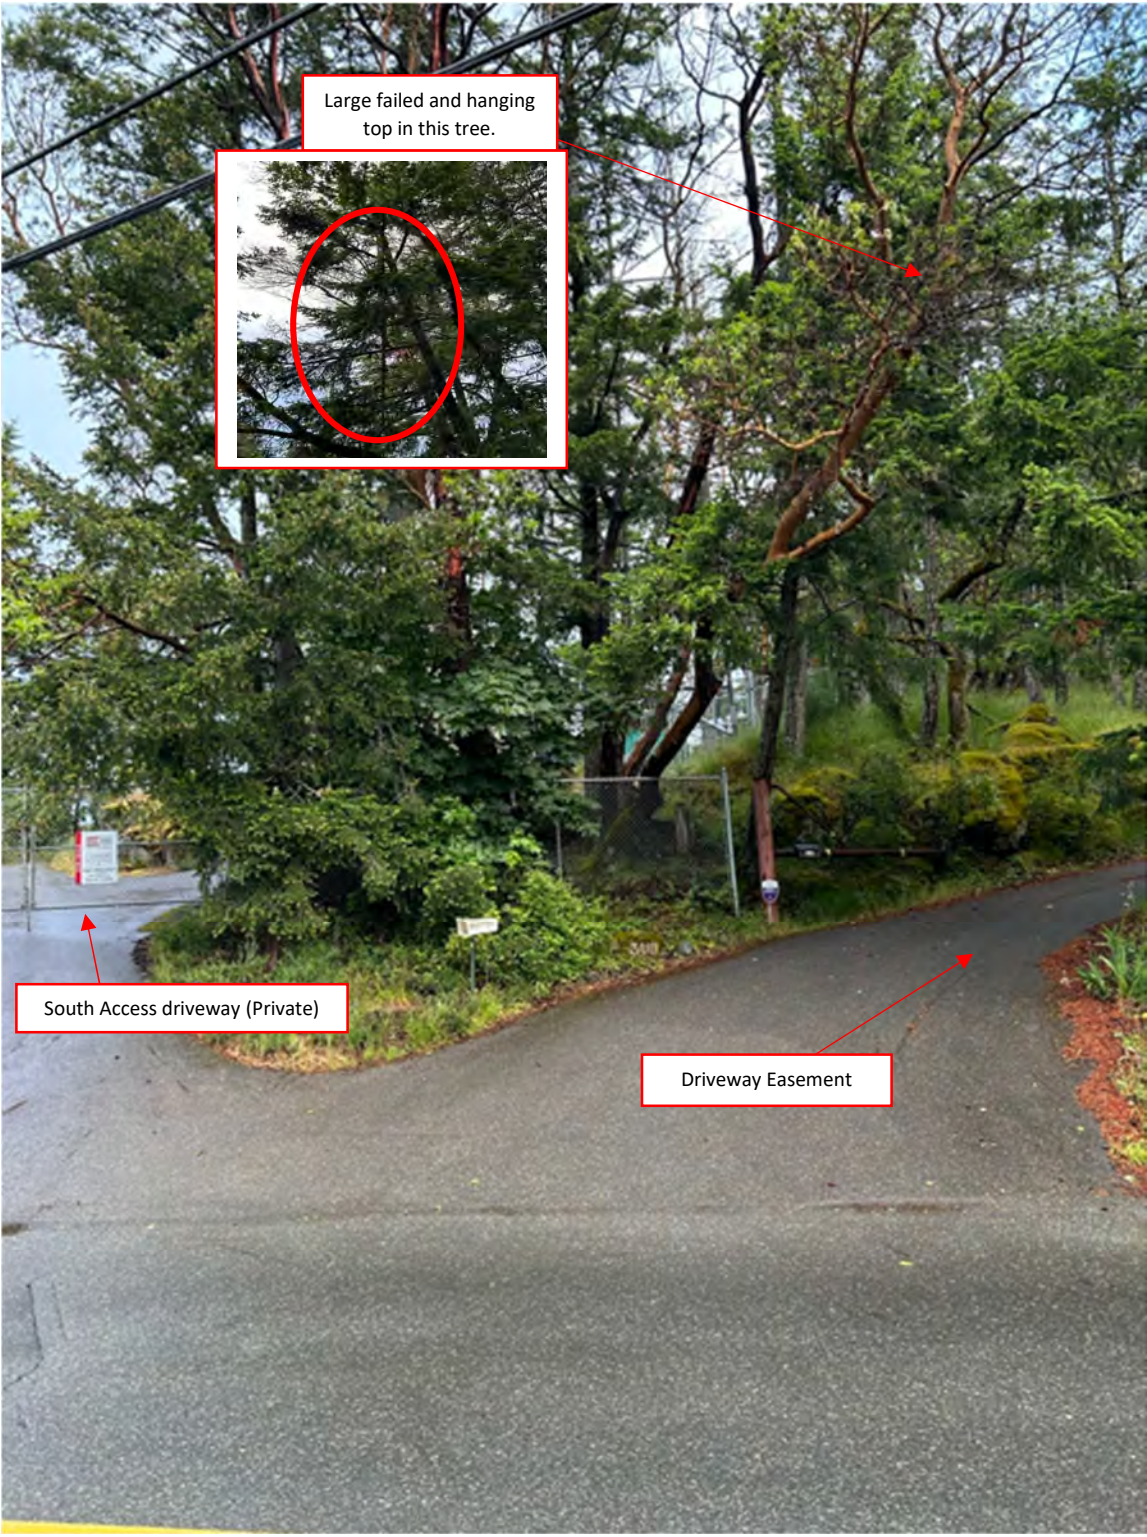
**Figure 12-** North facing from Fulton Rd. Municipal trees in poor condition.

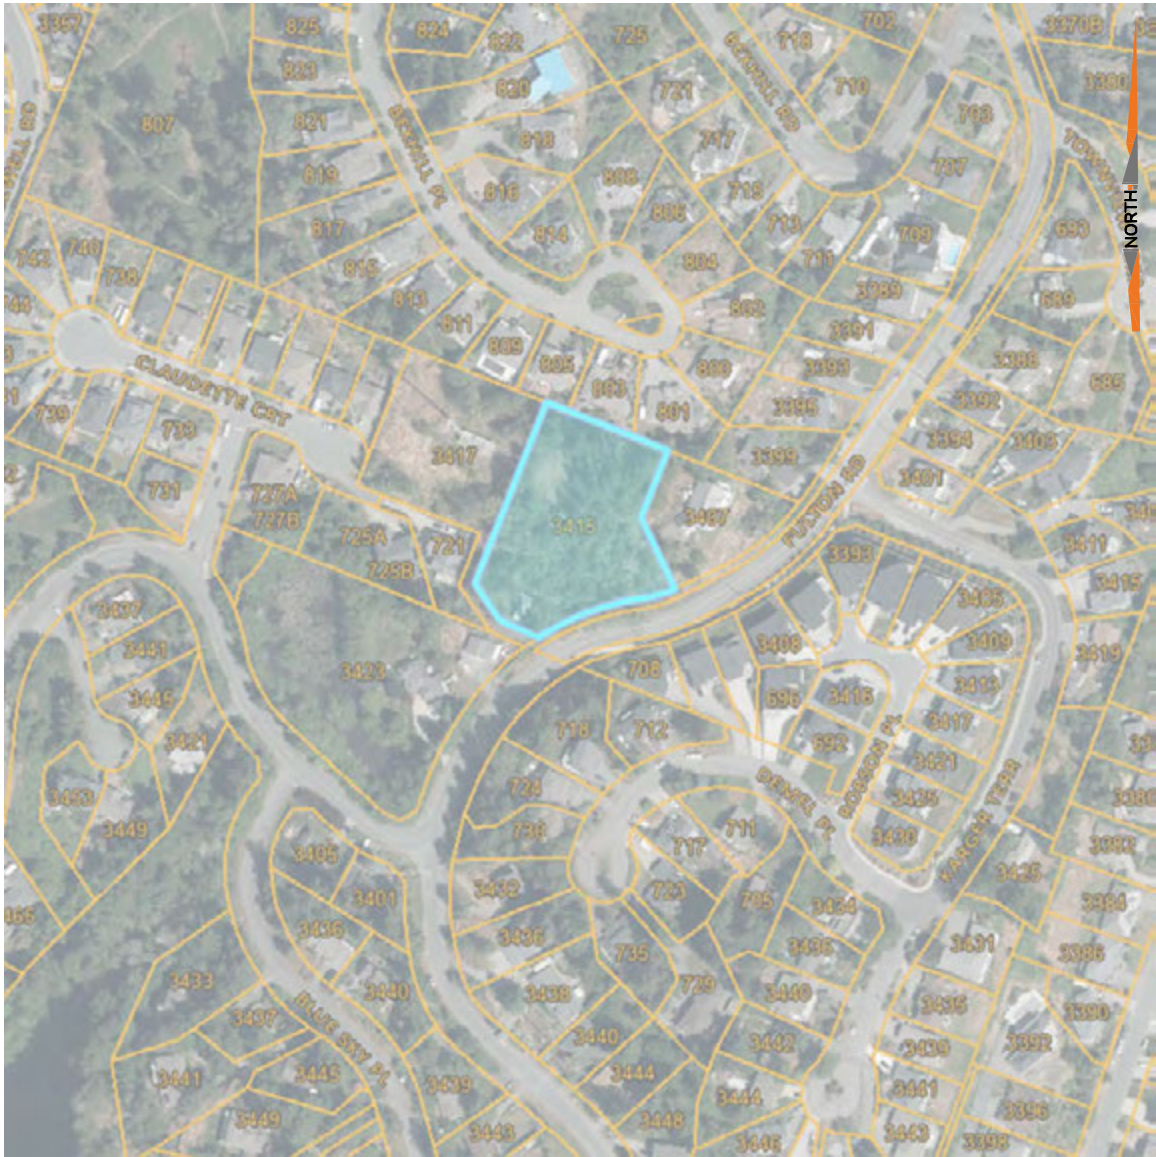
Figure 1  
Site Location

WATT Consulting Group is retained by David Fulkco to prepare a Transportation Impact Assessment (TIA) for a proposed townhouse development at 3415 Fulton Road in Colwood, BC. The site location is illustrated in **Figure 1**.

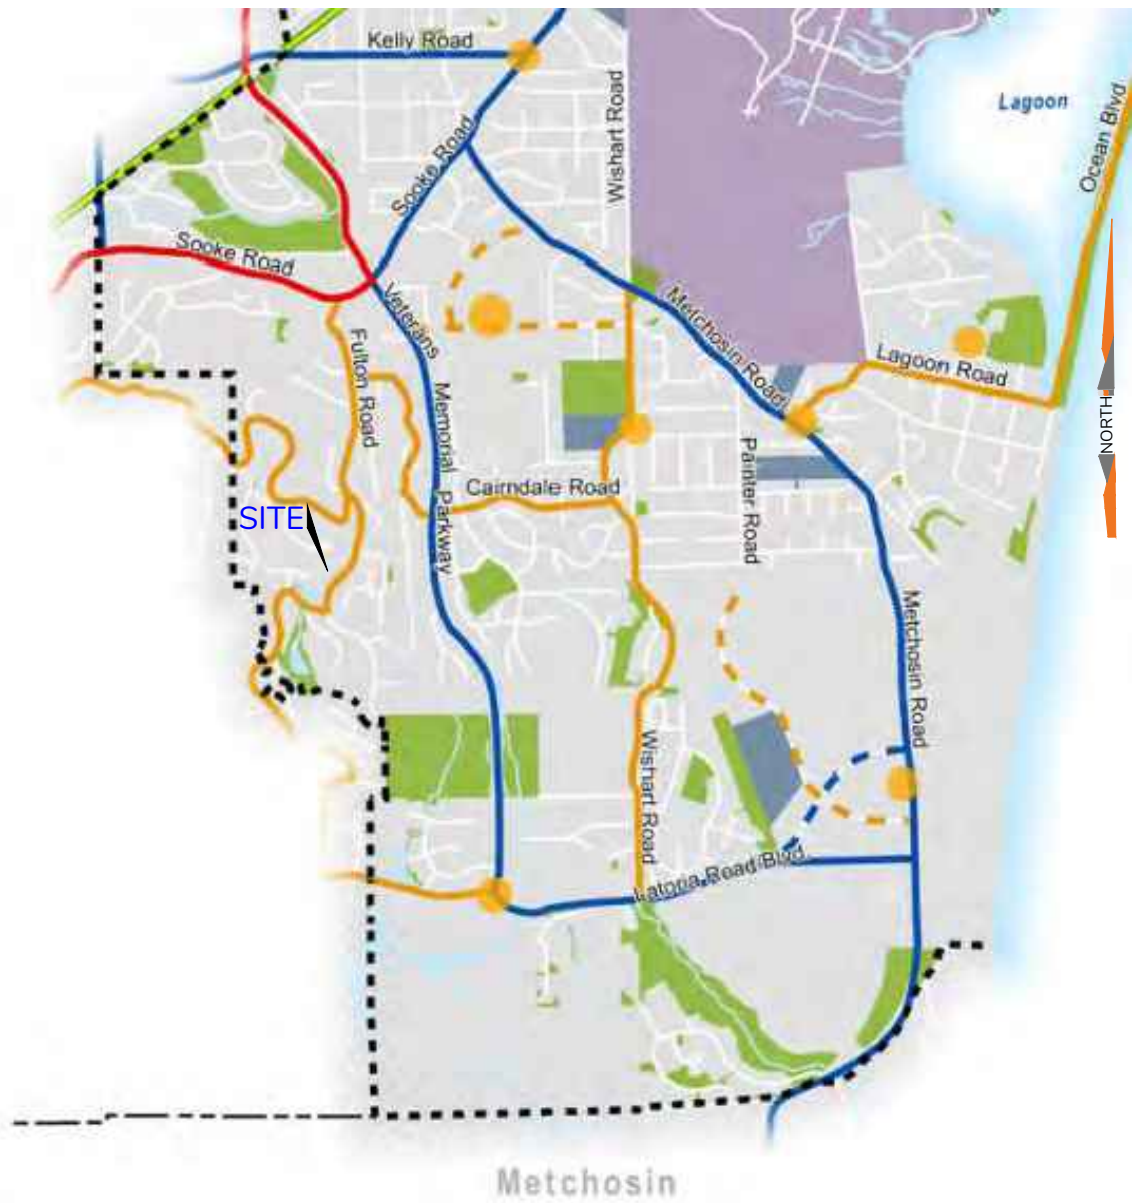
No road network changes are planned in the vicinity of the site west of Veterans Memorial Parkway. The existing road network, and changes proposed east of Veterans Memorial Parkway, are shown in **Figure 2**.

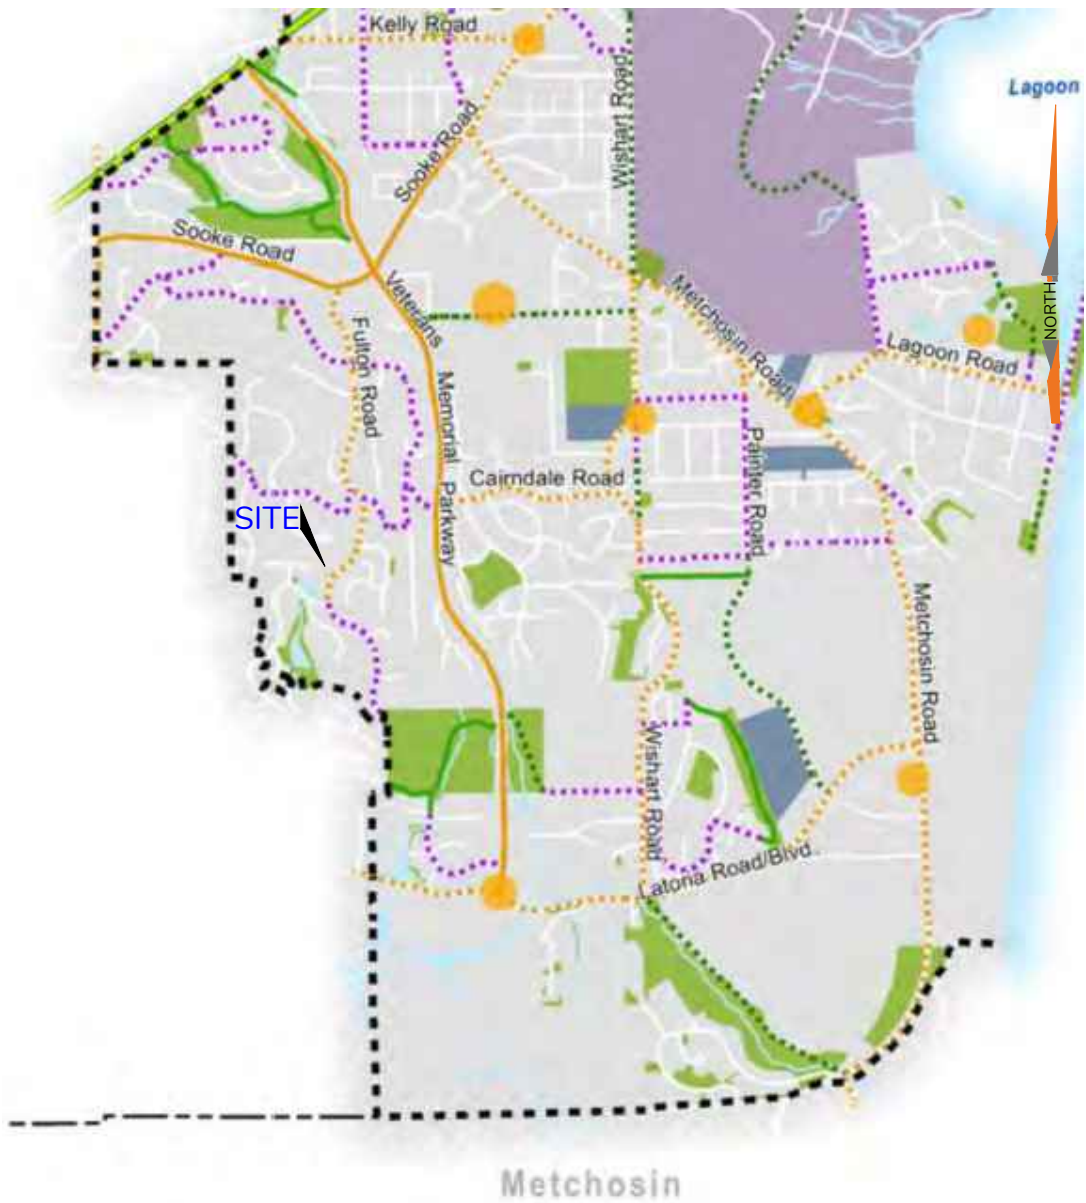
### Proposed Bicycle Network

Per the City's Transportation Master Plan (TMP), buffered bicycle lanes are proposed along Fulton Road which would connect the site to Sooke Road. Proposed neighbourhood bikeways would connect the buffered bike lanes to Veterans Memorial Parkway along a shorter route than via Sooke Road.

The nearest cycling facilities to the site are painted bike lanes on Veterans Memorial Parkway, an approximately 1.1 km ride away. Shoulder bikeways on Sooke Road are a 1.4 km ride away. The roads leading to these bikeways have many areas of steep grade (sometimes exceeding 20%). The existing cycling network in the vicinity of the site is illustrated in **Figure 4**.

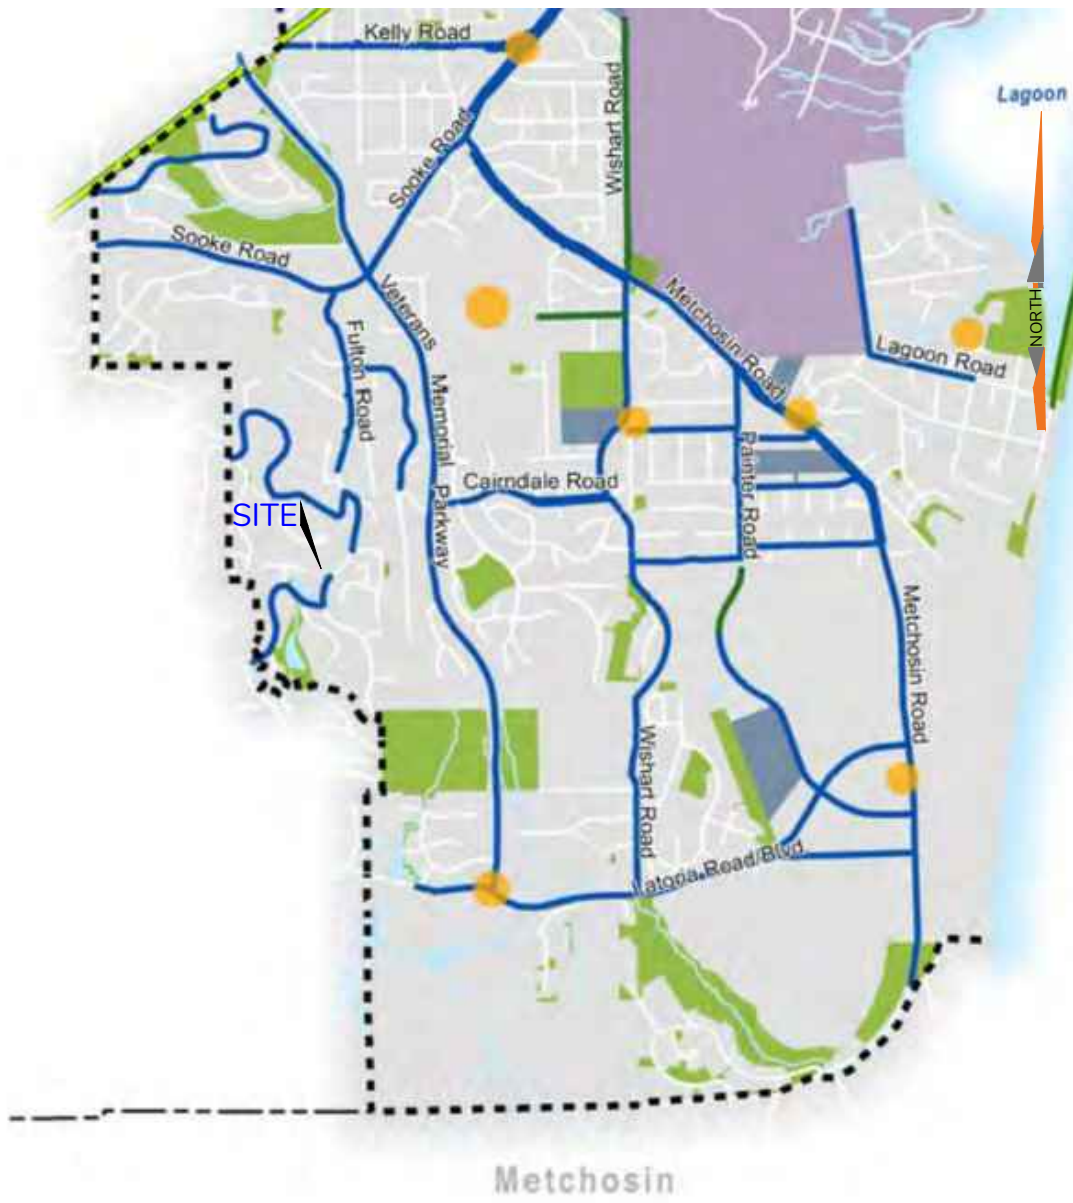
### Priority Sidewalk Improvements

Per the TMP, the City plans to extend the Fulton Road sidewalk to Sooke Road and add sidewalk to Haida Drive to connect to Veterans Memorial Parkway. Two westward sidewalk connections are also planned to residential areas in the adjacent City of Langford. These planned improvements are shown in **Figure 5**.
