Coburg Peninsula Foreshore Erosion Updated Study Report

City of Colwood

Our Reference: 661-01-2801998
Coburg Peninsula Foreshore Erosion:
Updated Study Report
Date of Issue: February 27, 2008

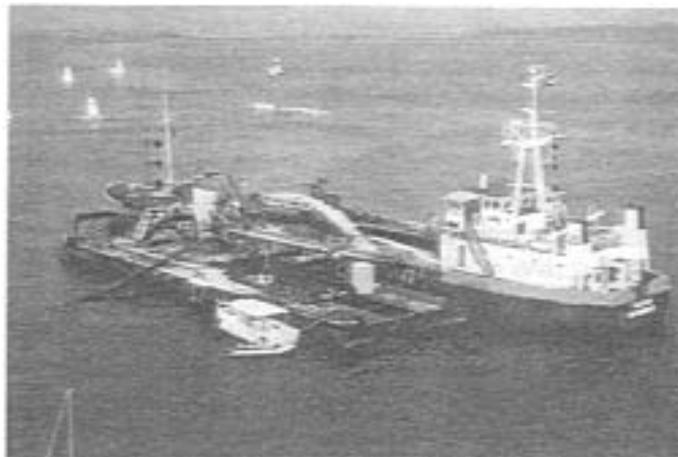
The Pelican Dredge used on the Adelaide Coastline

The success of this operation was reflected in the Government's endorsement to undertake a further trial dredging operation in 1991 from an offshore sand source at Port Stanvac. "The Pelican" was again contracted, after a public tender call, to dredge approximately 100,000 cubic metres of sand from Port Stanvac and discharge it onto the beach at Brighton. Towards the end of the contract, the dredging company indicated that the Government could make a potential saving of about \$0.5M on mobilisation costs if the programmed 1991/92 metropolitan beach replenishment program was undertaken while "the Pelican" was in Adelaide. After an assessment was made of the dredging operation and costs, the Minister for Environment and Planning agreed to an extension to the contract based on the contractor's offer. A further 100,000 cubic metres was dredged from the Port Stanvac site. The cost of this 200,000 cubic metre dredging program was about \$11 per cubic metre (including mobilisation costs) or \$8 per cubic metre if mobilisation costs are excluded. The beach replenishment program averaged about 200,000 cubic metres per year in the three year period from 1988.

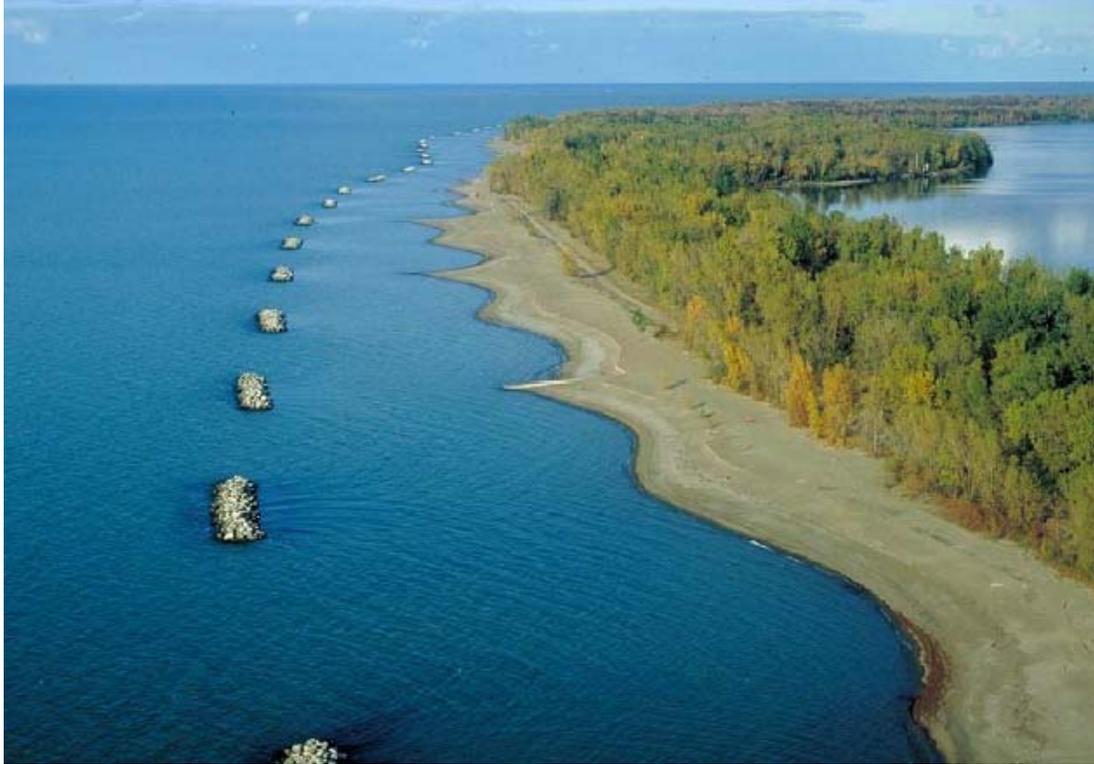
Offshore Breakwaters, Presque Isle, Pennsylvania
Excerpt from US Army Corps of Engineers Coastal Engineering Manual, Report EM 1110-2-1100
EM 1110-2-1100 (Part V), 1 Jun 06, Figure V-3-19

In the case of offshore breakwaters, a length of about 180 m per structure at a spacing of about 300 m has been assumed. An offshore breakwater functions by interfering with incident waves causing diffraction in the lee of the structure. The diffracted wave pattern enables a tombolo to build in behind the breakwater. As in the case of groynes, the Coburg Peninsula doesn't have any sediment to give up so the structures would have to be backfilled in the tombolo area as part of their construction. Material excavated for the foundation structure could be used for this.
