File: DP000016 - Pool and Accessory Building at 3341 Betula Pl

DEVELOPMENT PERMIT DP000016

Re: 3341 Betula Place, Colwood, Construction of pool and accessory structure.

Re: Proposed Accessory Building Geotechnical Assessment
3341 Betula Place – Colwood, BC

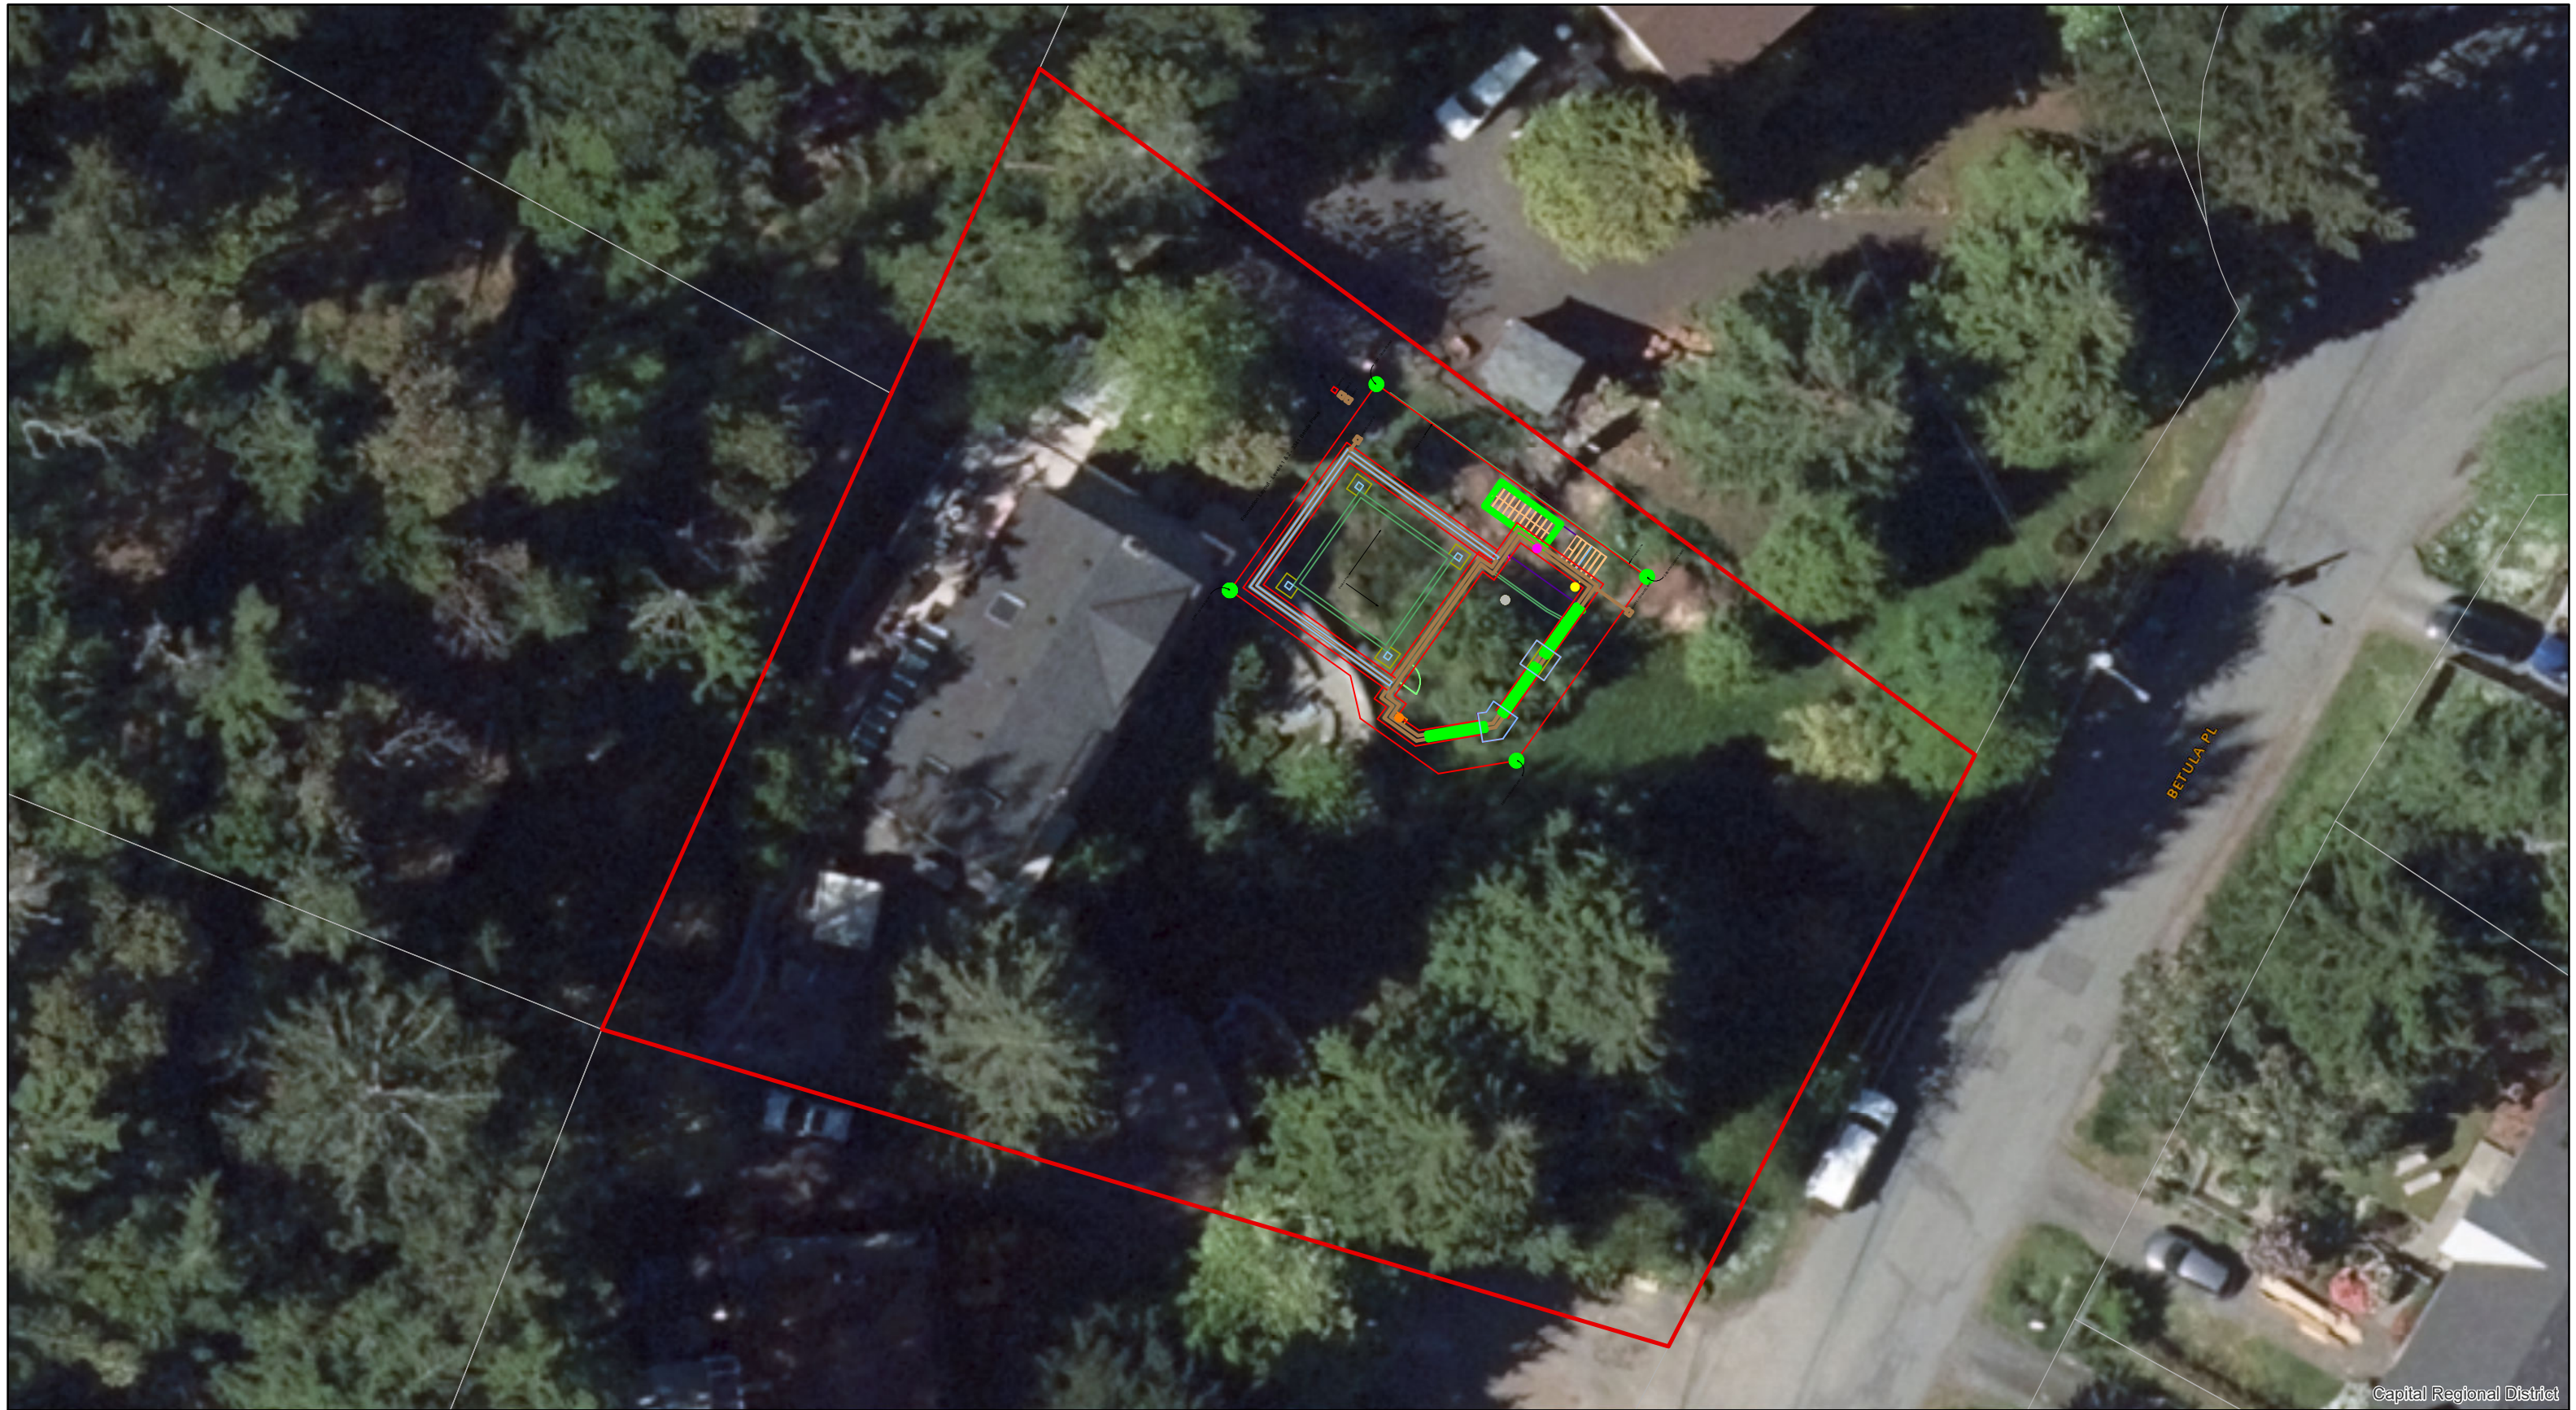
Figure 1

Under Section 23.1 guidelines for development on steep slopes, Corvidae has calculated the slope at the proposed development to be 22% (4 m rise, 18.2 m run) – (see *Figure Figure 1*). Therefore, the Natural Hazards DPA does not apply.

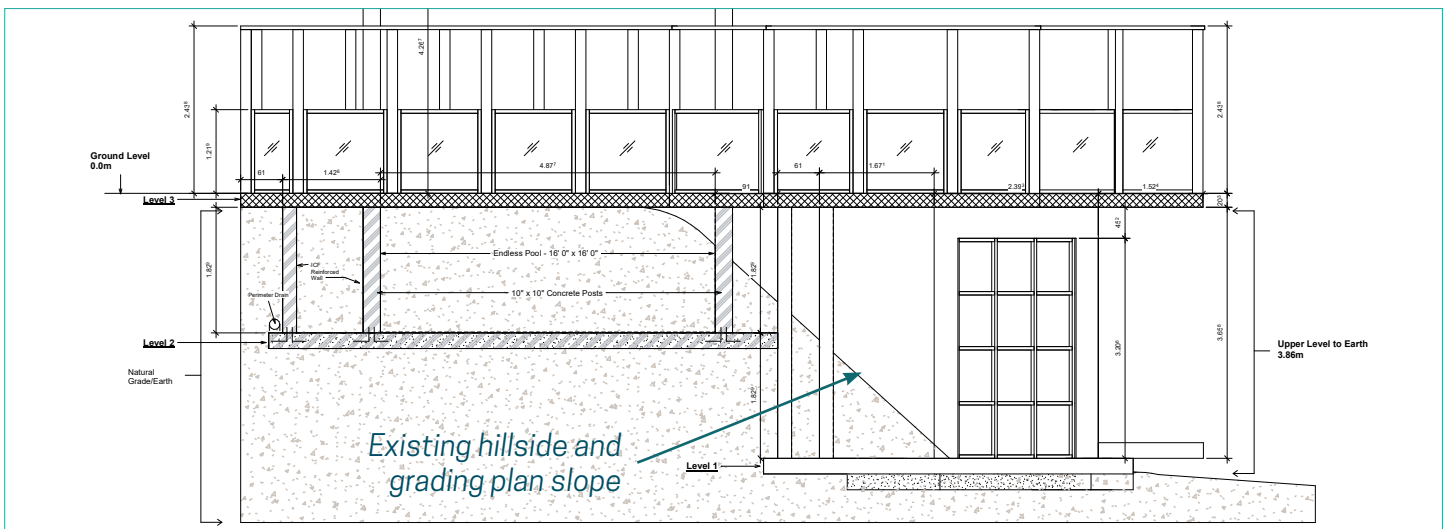
West elevation of proposed project, showing pre-construction slope.
